# *Complete Home Inspections LLC*

## Property Inspection Report

1001 W 1st St., Muncie, IN 47305

Inspection prepared for: Costas Themis

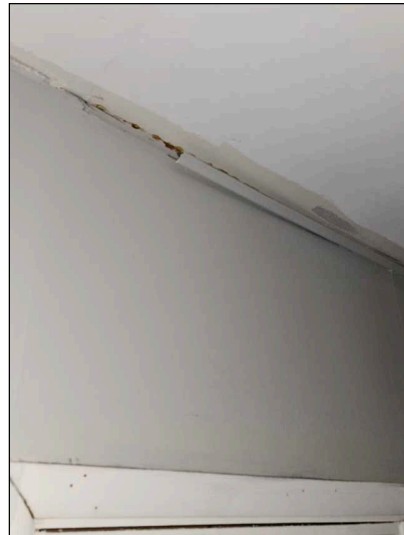
#### 6. Ceiling Condition

- There were several areas that were unfinished or had minor deterioration of the plaster ceilings. No active leaks observed at the time of the inspection. Recommend further evaluation by a qualified contractor.

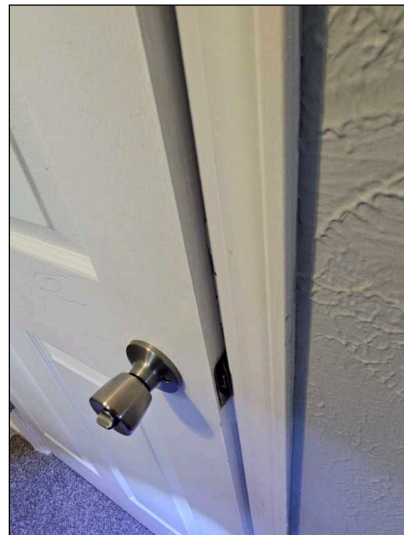
- Issues with operating every door in the house. Tight fitting. Difficult to open and close or does not latch properly. Recommend repair by a qualified contractor.

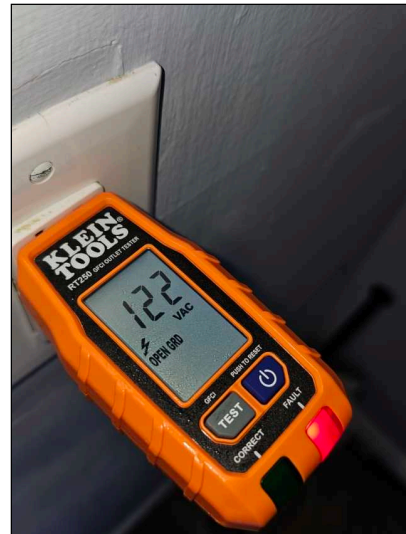
- GFCI outlet in the bathroom of unit #2 was not functional. No power indicated when tested and would not reset. Recommend replacement by a licensed electrician.
- GFCI outlet in the bathroom for unit #1 was found to have an open ground fault when tested. Recommend a licensed electrician to repair the issue.

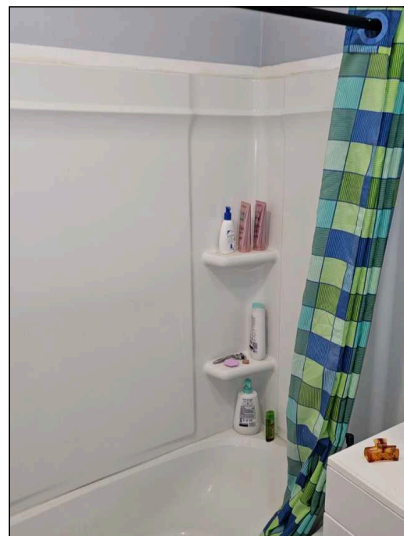
### 15. Bath Tubs

Observations:  
• Bathtub noted

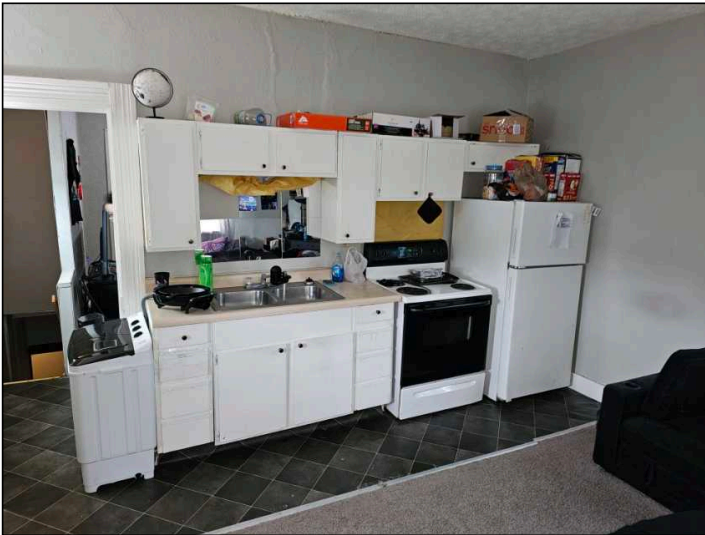
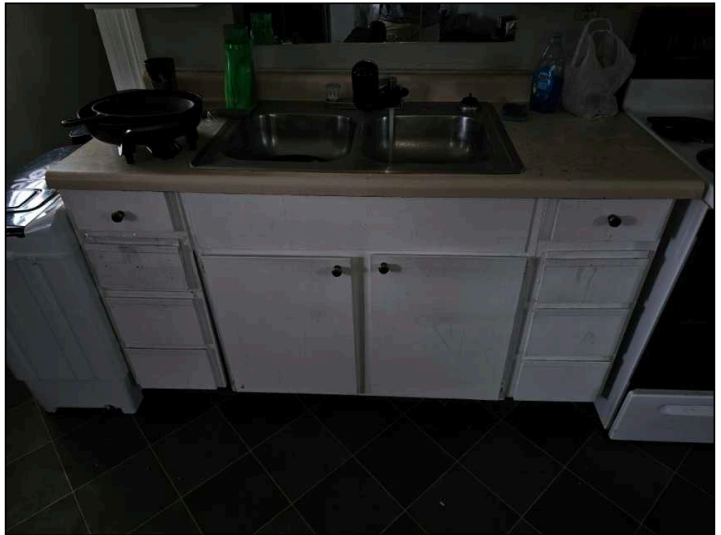
- Cabinets appeared to be beyond the expected lifespan. Consider upgrading
- Some cabinet doors need magnets or hardware to stay shut. Repair as needed.
- Some cabinet drawers need hardware repair/adjustment (to stay shut). Repair as needed.

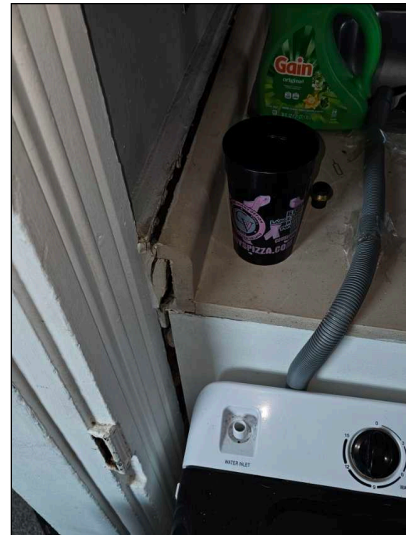
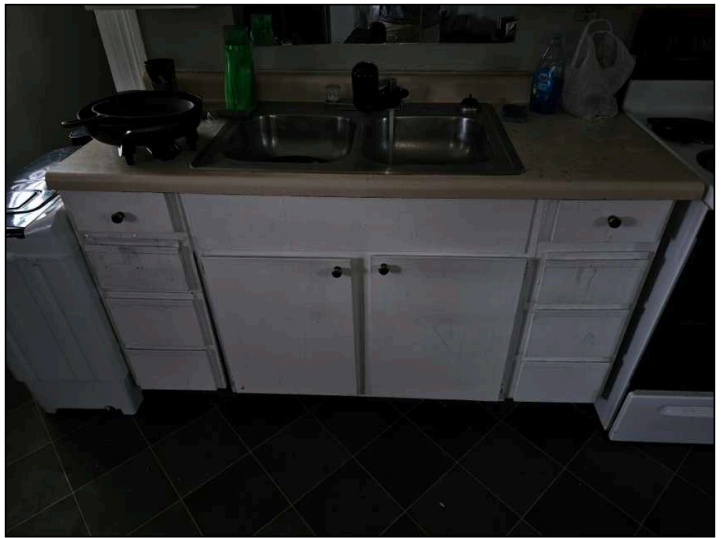
## 2. Counters

- Plastic laminate tops noted.
- Particle wood exposed on edge of the countertop in the kitchen of unit #1. This makes the countertop susceptible to moisture damage. Recommend repair by a qualified contractor.
- Countertop in the kitchen of unit #2 appears to be beyond the expected life span of the material. Recommend considering new cabinets and countertop.

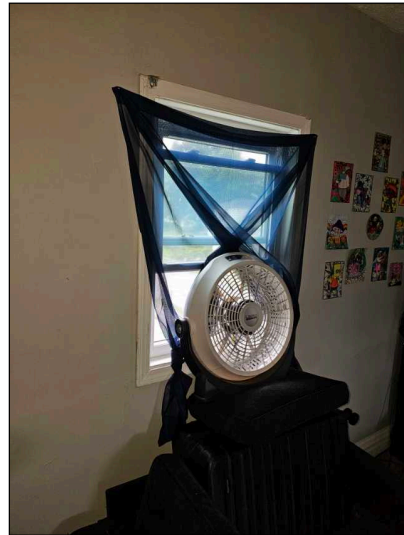
## 9. Window Condition

- Operated windows appeared functional, at time of inspection.
- Not all windows were tested due to personal items and furnishing obstructing the windows.

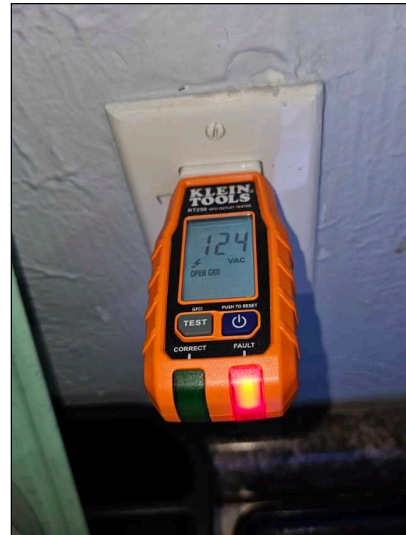
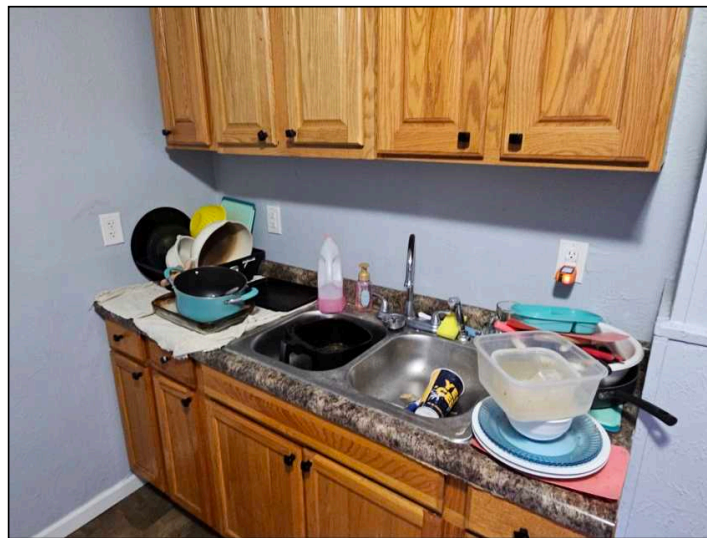
- Not all outlets in the kitchen were GFCI protected. While it may not have been required when the house was built. We suggest buyer consider upgrading with GFCI's at all receptacles near water sources.
- GFCI tested and found to be improperly wired. Potential shock hazard in a high moisture area. Recommend review and repair by a licensed electrician.

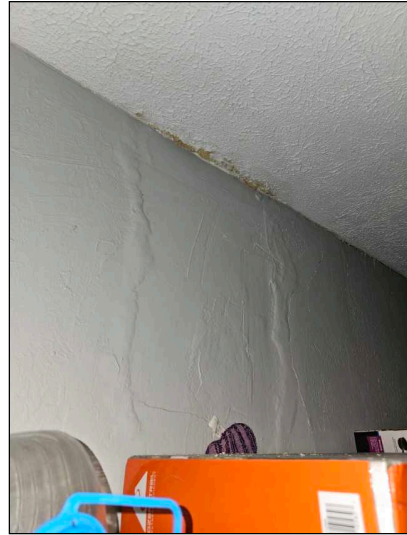
### 15. Wall Condition

- Limited review due to storage of personal property and finished walls.
- There is evidence of moisture entering structure in the kitchen in unit #2. We recommend contacting a contractor experienced in exterior systems to evaluate the area and suggest repair options.
- Paper covering wall above stove is possible obstructing damage to the wall.

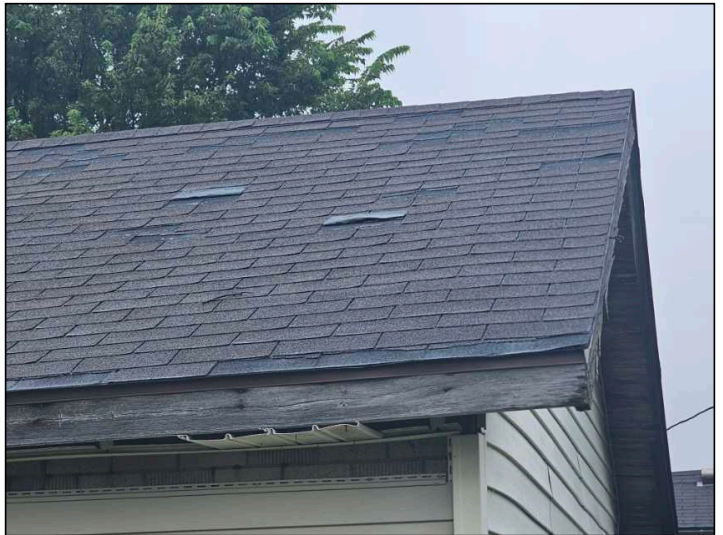
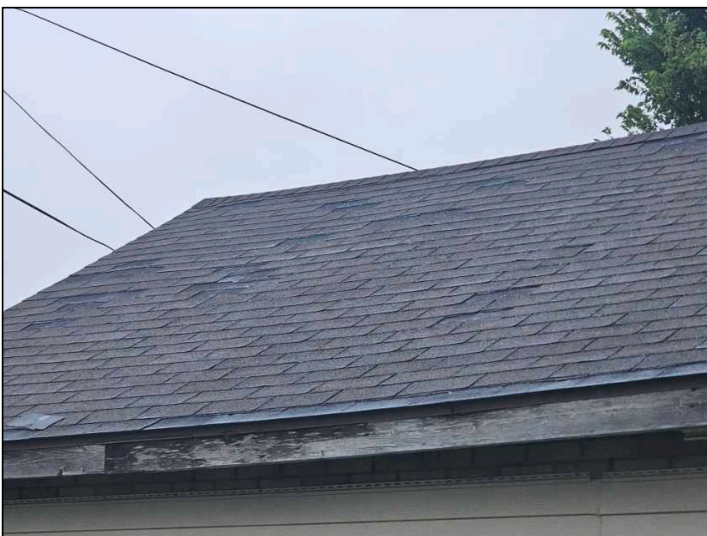
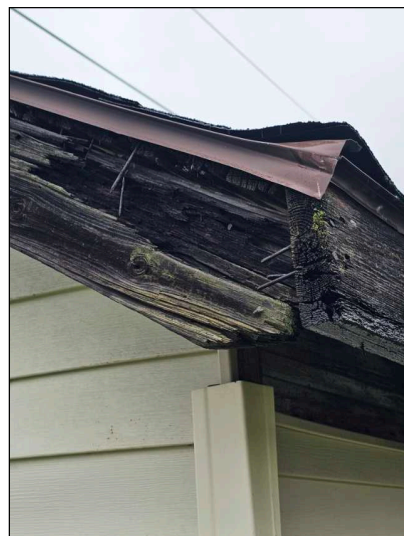
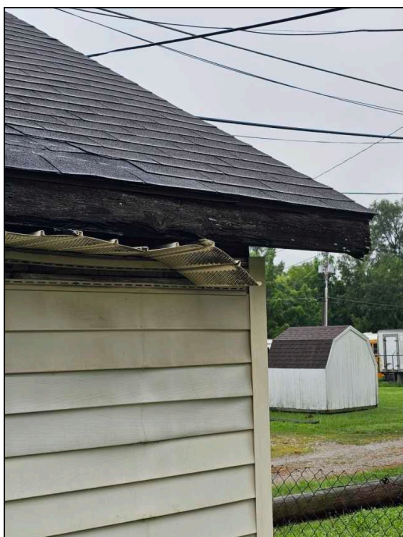
- Some shingles and/or tabs missing.
- Some shingles damaged.
- Roof sheathing has been damaged.
- Indications of past or present water leaks, seeps, or condensation at eaves.
- Recommend further evaluation for repair/replacement by a qualified roofing contractor.
- Deterioration of exposed wood noted at the eaves around the garage. Recommend repair by a qualified siding contractor.

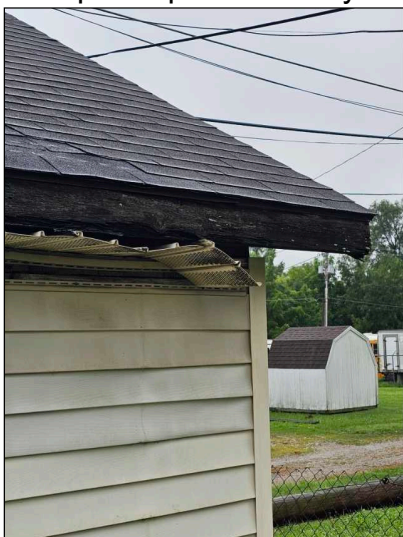
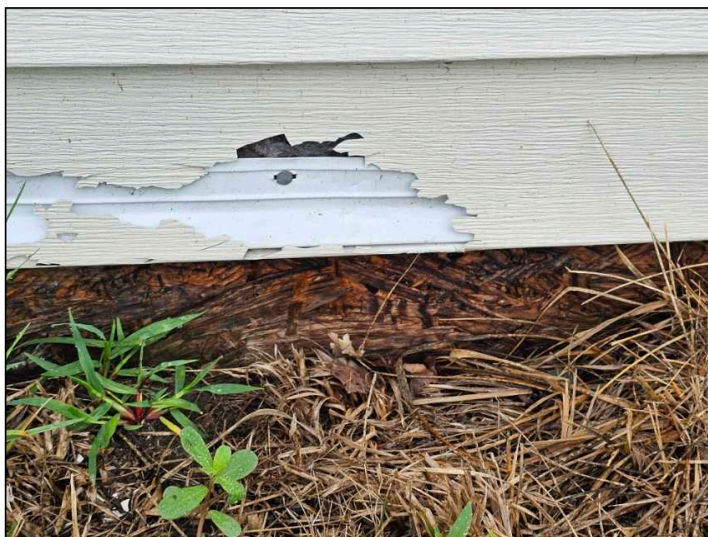
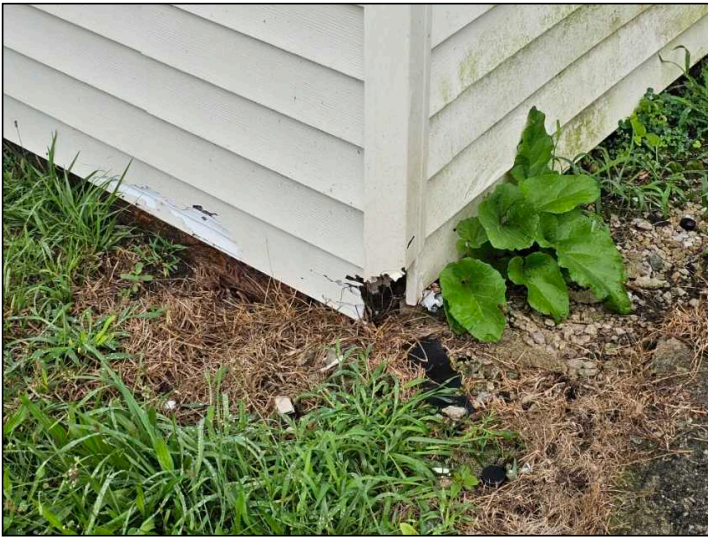
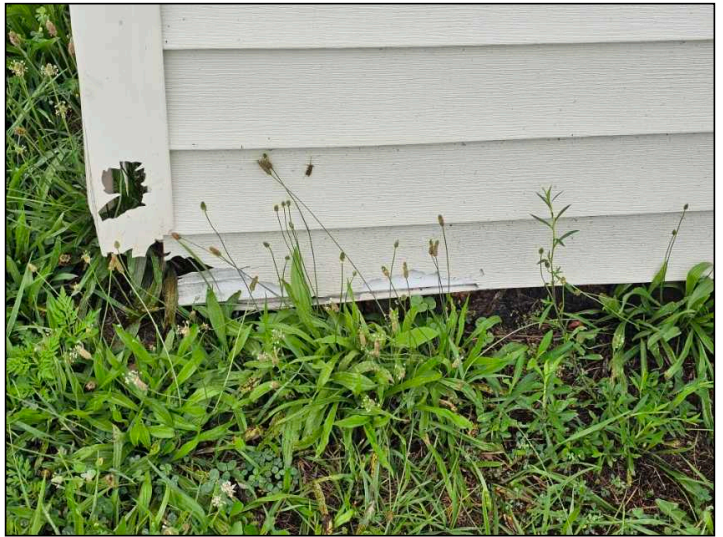
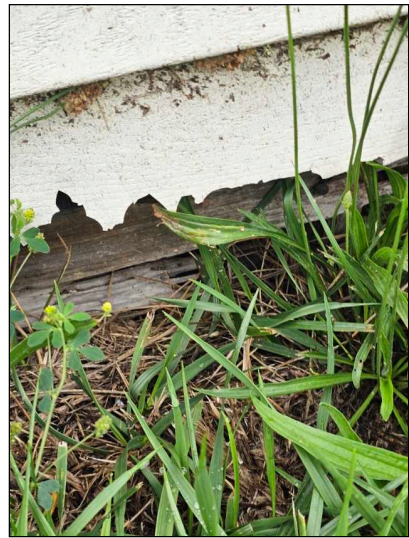
## 2. Walls

- The interior of the detached Garage/Shed could not be inspected due to restricted access. No key was available to unlock the exterior door at the time of inspection.
- Exterior siding is missing and damaged in multiple areas and is in close proximity to the ground. These issues can allow water damage to occur. Recommend repair/replacement by a qualified contractor.

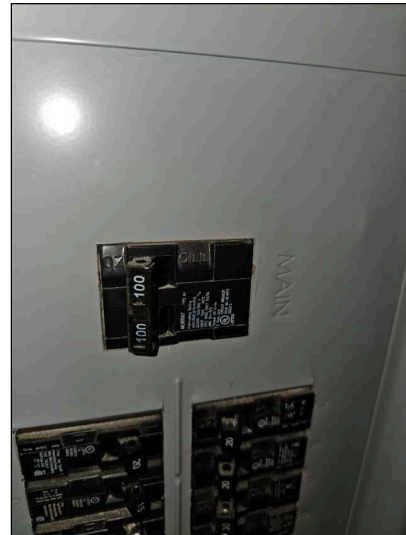
- Open breaker panel slot(s) at panel box cover in unit 2. Electrocution hazard. Recommend repair by a licensed electrician.

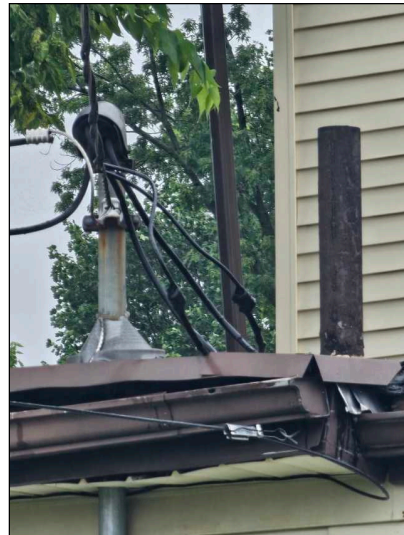
- There is an overhead service drop noted.
- The weather head is too low and the driploop is resting on the metal roof, this is a serious safety concern. Recommend review by a licensed electrician for repair or replacement, as necessary, prior to close.

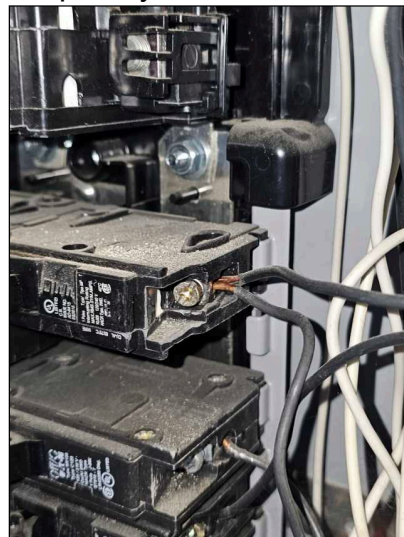
## 5. Breakers

- All of the circuit breakers appeared serviceable in both units with exception of one breaker that had a broken switch in unit 1. Recommend replacement by a licensed electrician.
- Double tapping observed in unit #1. Double tapping (i.e. 2 wires on a single pole breaker) can add to the load of the affected circuit causing a possible overload and tripping breakers, or result in loose connections and overheating of the breaker or connections. Recommend further evaluation and repair by a licensed electrician

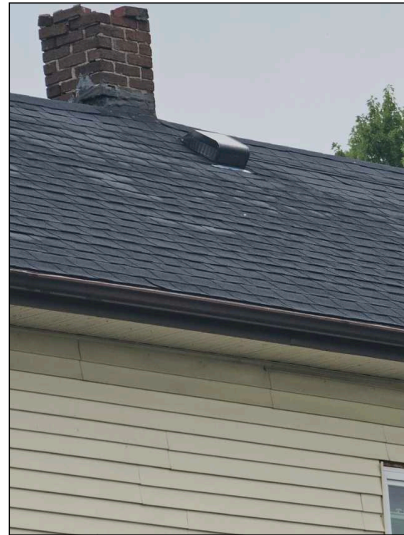
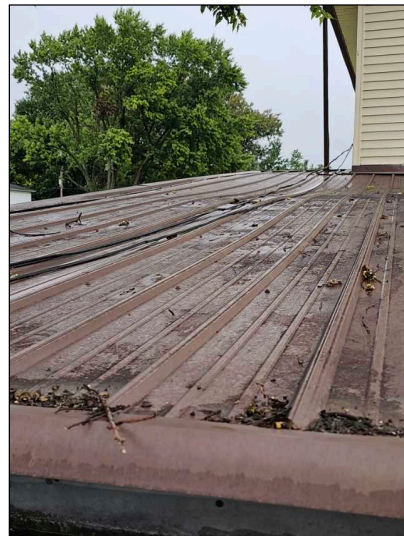
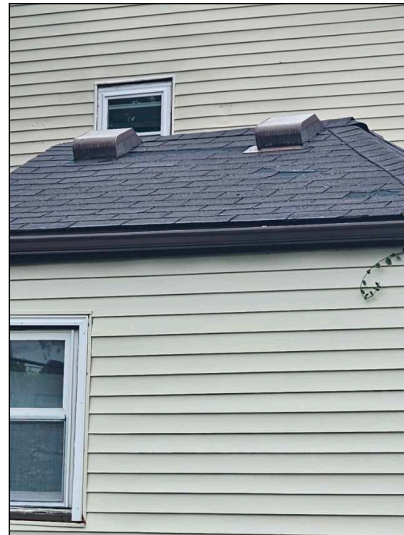
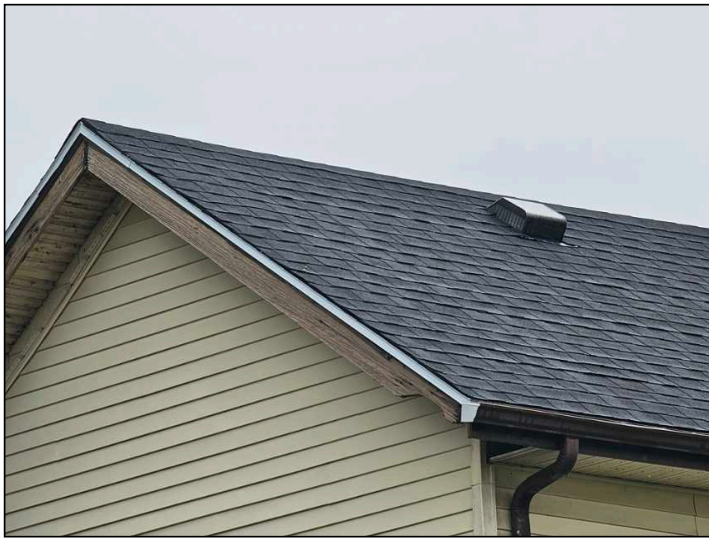
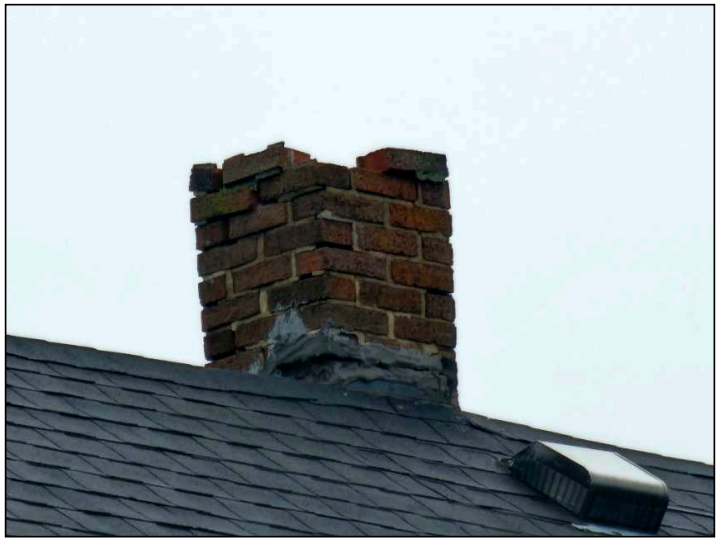
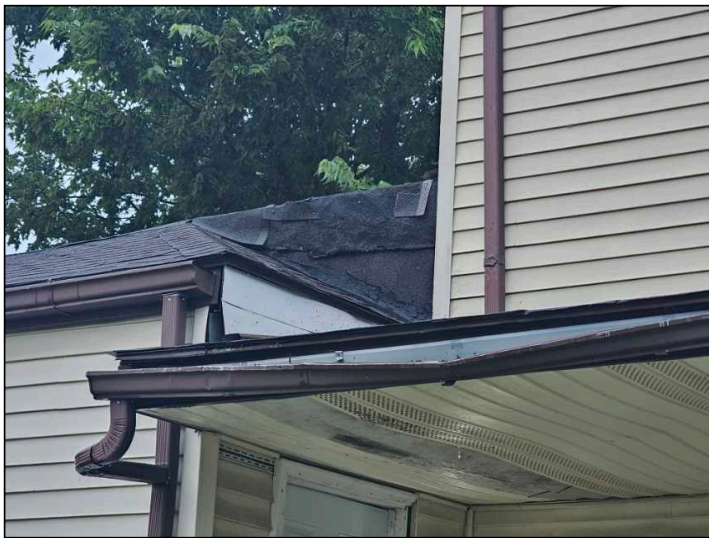
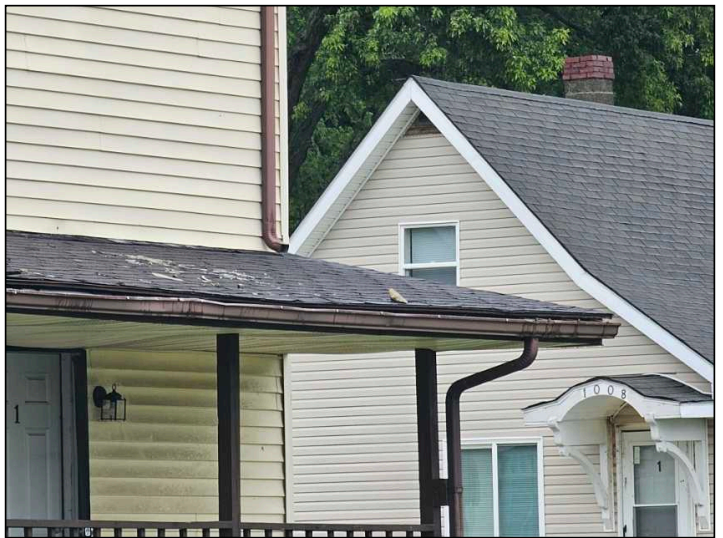
## 1. Roof Condition

- Some shingles &/or tabs missing.
- Some shingles curling.
- Some shingles damaged.
- Recommend roofing contractor to evaluate.

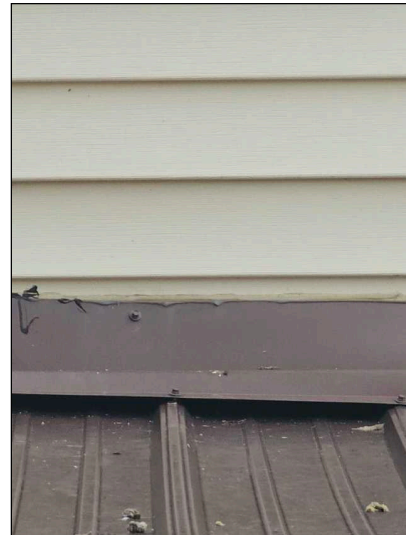
## 2. Flashing

- Flashing is missing around the chimney. Recommend a qualified roofing contractor to further evaluate the roof.
- The caulking was deteriorating on the flashing around the metal roof. Recommend resealing to prevent leaks.

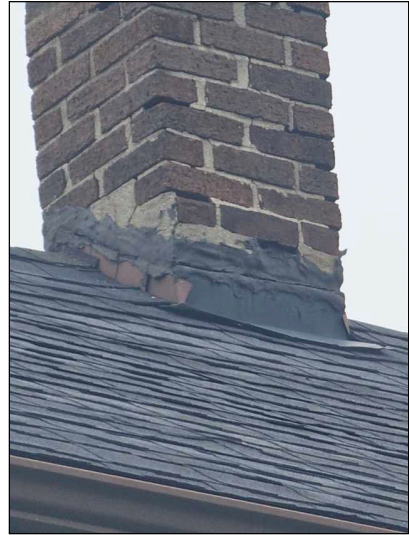
### 3. Chimney

- No chimney cap visible from inspection level. Recommend installation to prevent weathering, water intrusion, and nesting of wildlife.
- Chimney Mortar shows sign of deterioration. Recommend having repaired as necessary.
- Brick and mortar deterioration observed; repair advised.

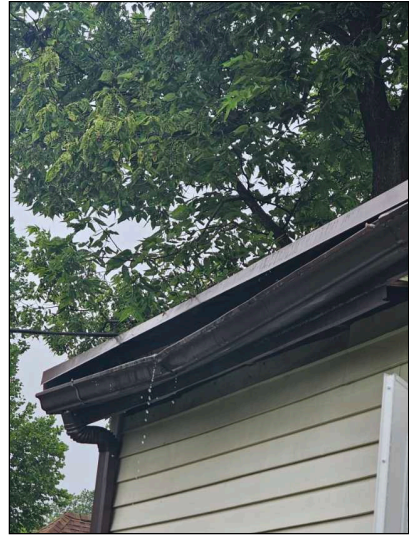
- The gutters were damaged or missing in multiple areas around the house. Recommend further review and repair/replacement as necessary by a qualified gutter company to keep water away from the foundation.
- Missing/fallen downspouts noted.
- Downspout on the south side of the house discharges straight down towards foundation. Suggest adding a splash block or extension.

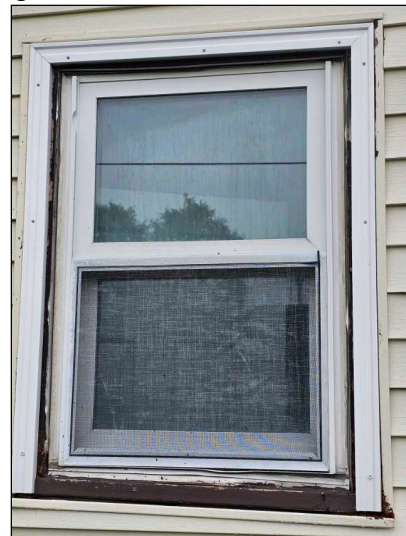
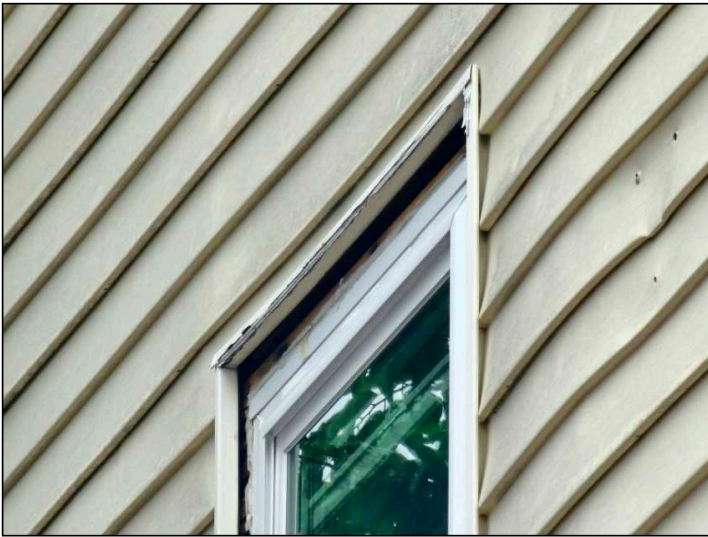
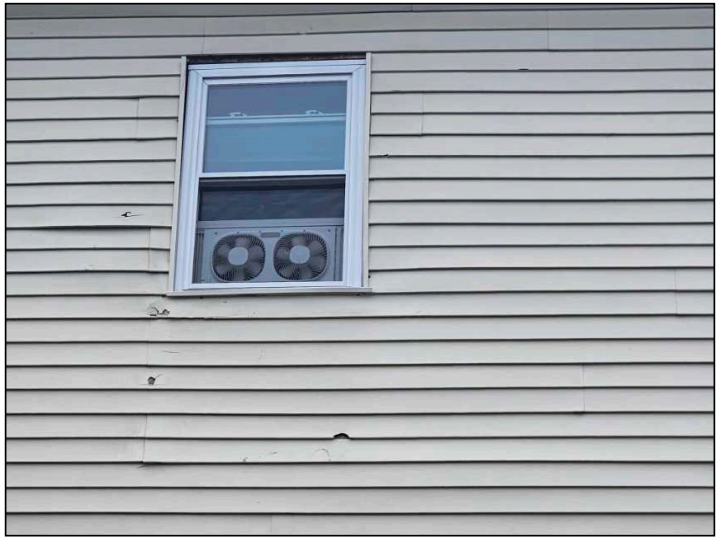
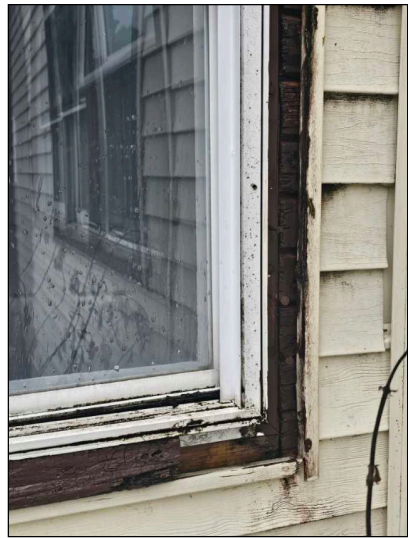
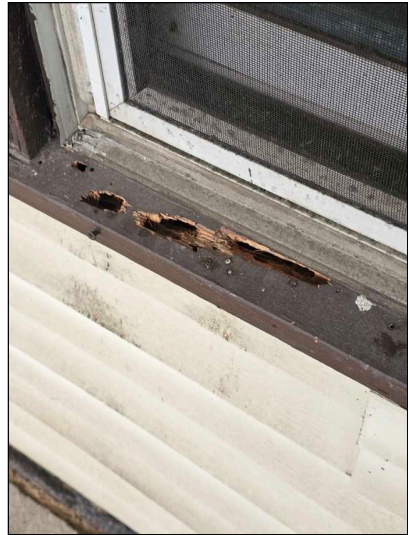
## 2. Window Condition

- Some window screens missing or damaged.
- Deteriorated exterior wood trim noted on several windows. Recommend repair/replacement by a qualified contractor.
- There is exposed wood around several of the windows. This can cause moisture damage. Recommend repair by a qualified siding contractor.

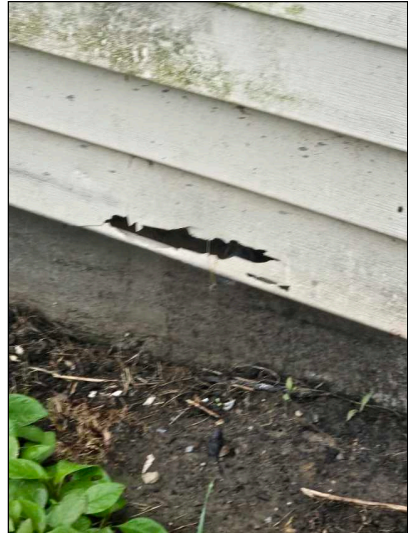
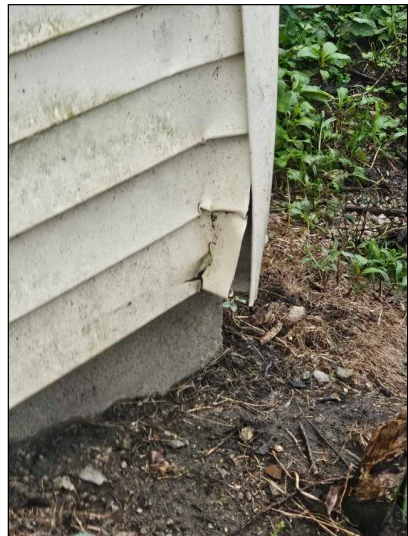
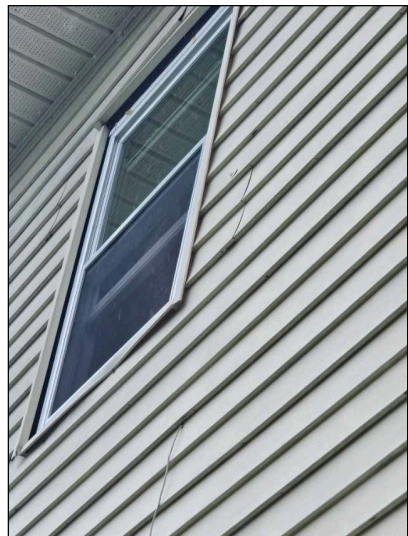
### 3. Siding Condition

- The siding is in close proximity to the soil. This may provide entrance for moisture or insects.
- Vinyl siding missing, damaged or improperly installed in multiple areas exposing the wood sheathing and can cause moisture damage. Recommend further evaluation by a qualified siding contractor.
- Warped siding present in some areas; recommend repair or replacement as necessary.
- Insect damage or activity suspected. Recommend further evaluation by a licensed exterminator.
- Some wood deterioration noted at garage - exterior personnel door frame base. Have repaired and inspected for wood-destroying insect damage.
- Moderate damage to vinyl: The vinyl siding covering exterior walls had areas of moderate damage which should be repaired to prevent moisture intrusion of the wall assembly.

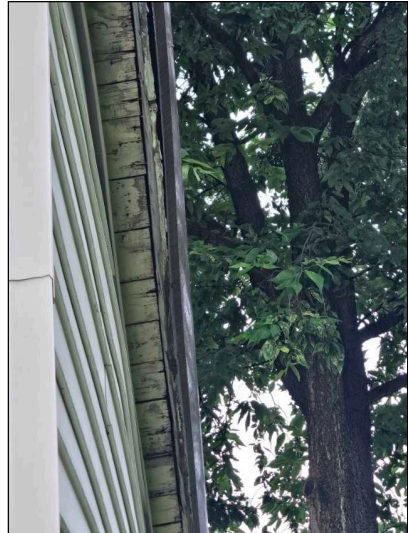
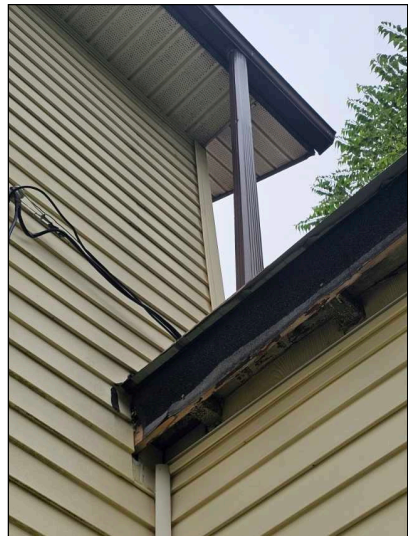
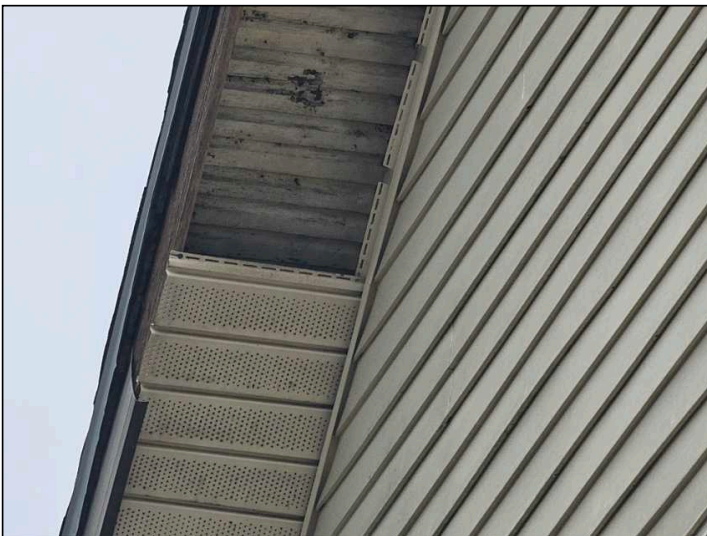
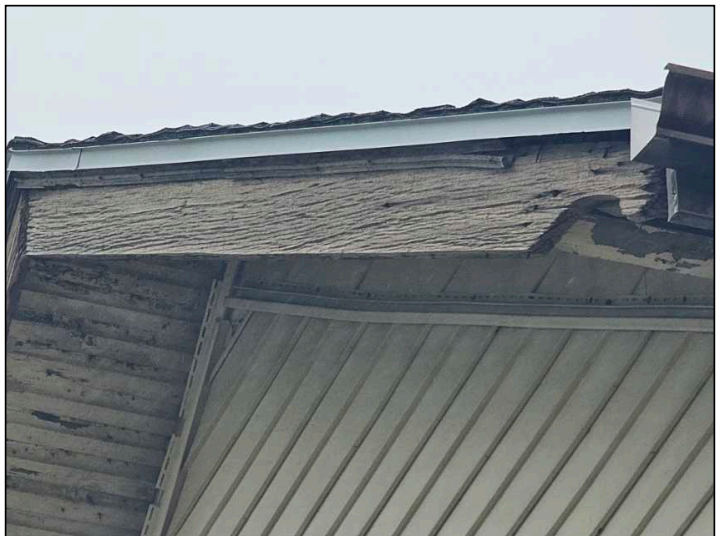
- In the inspectors opinion the trim is near the end of its useful life
- Moisture damage, wood rot, observed. Recommend review for repair as necessary by a qualified contractor.

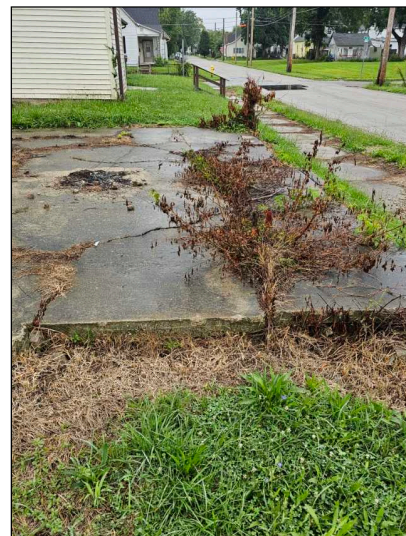
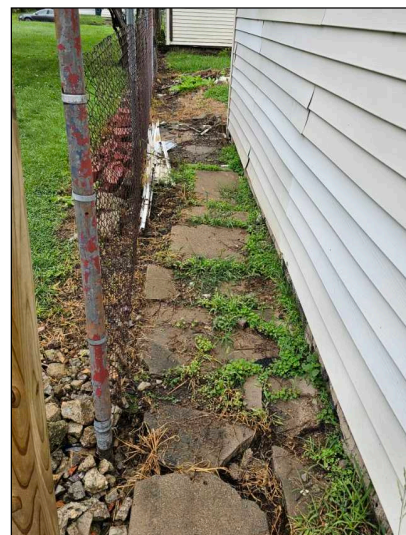
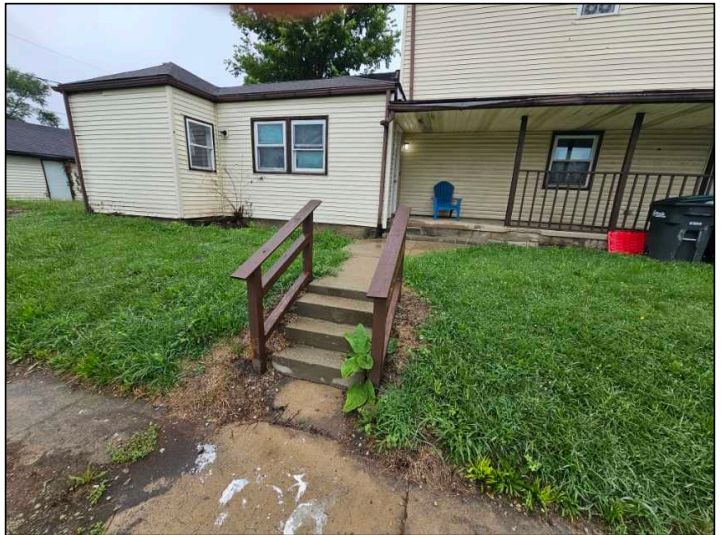
- There are numerous areas of damaged concrete surfaces. Concrete replacement is expensive. Recommend a concrete specialist provide an estimate for repair and or replacing.
- Monitor: Surface deterioration observed at the concrete surface.
- Potential Trip/fall Hazard(s) at the sidewalk steps and old concrete pad located in the backyard; monitor/ repair as necessary.
- Handrail on sidewalk steps is no graspable by today's standards and is a potential fall hazard. Recommend a qualified contractor to replace handrails.
- Sidewalk along the garage/shed is severely deteriorated and is a potential tripping/fall hazard. Recommend repair by a qualified contractor.

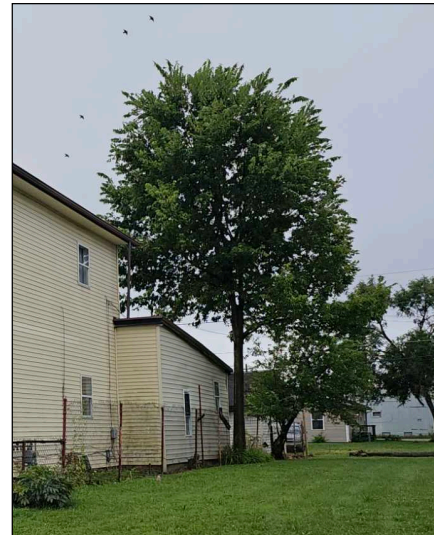
### 3. Vegetation Observations

- There is a tree on the neighboring property that is within 6 feet of house. Monitor for potential root damage to the foundation and possible damage to the roof from tree limbs.

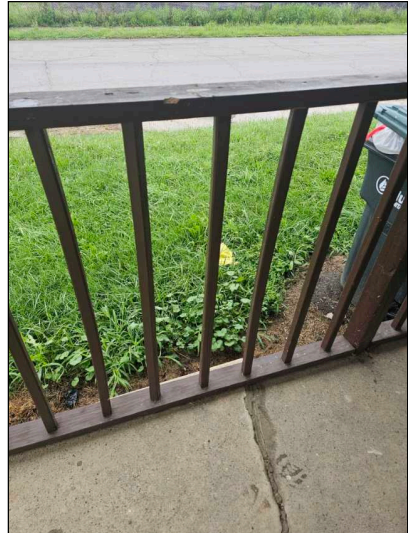
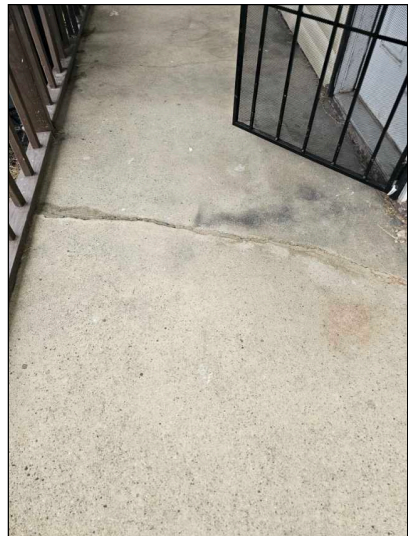
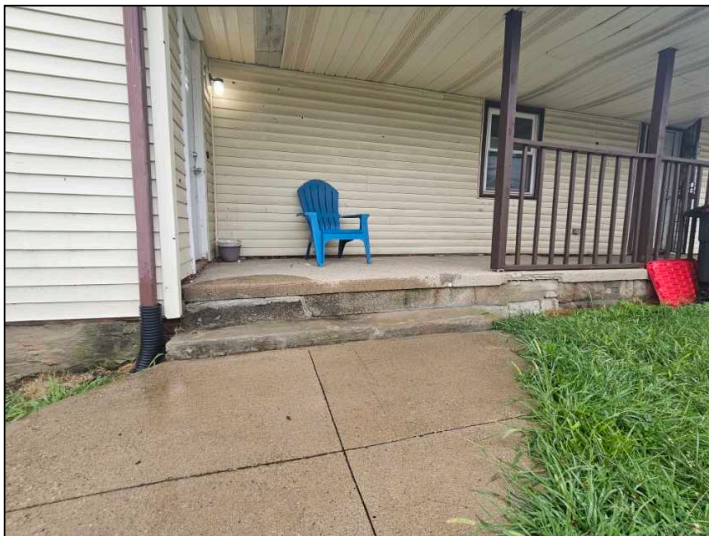
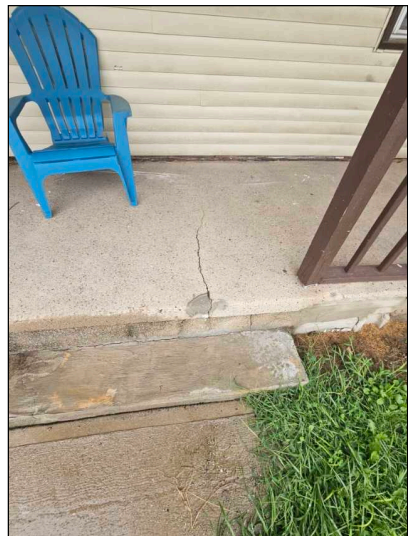
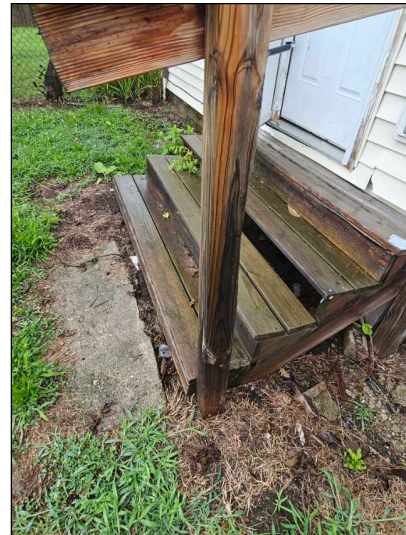
### 4. Patio and Porch Deck

- Balusters spaced to far apart.
- Non-conforming steps on the front patio, possible safety hazard.
- The steps are slanted on the back door of the downstairs unit and present a possible slipping hazard.
- Front concrete patio has a large settlement crack that caused the surface to be uneven. This is a potential tripping hazard. Recommend repair/replacement by a qualified contractor.

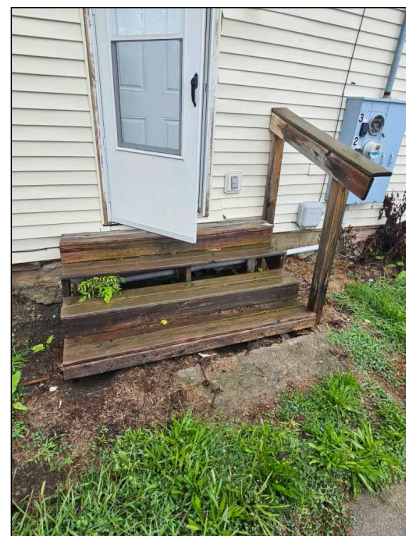
## 5. Stairs & Handrail

- Handrails are not graspable. By today's standards, rails should be configured so that a hand may grasp around a rail for safety. Recommend replacement by a qualified contractor.

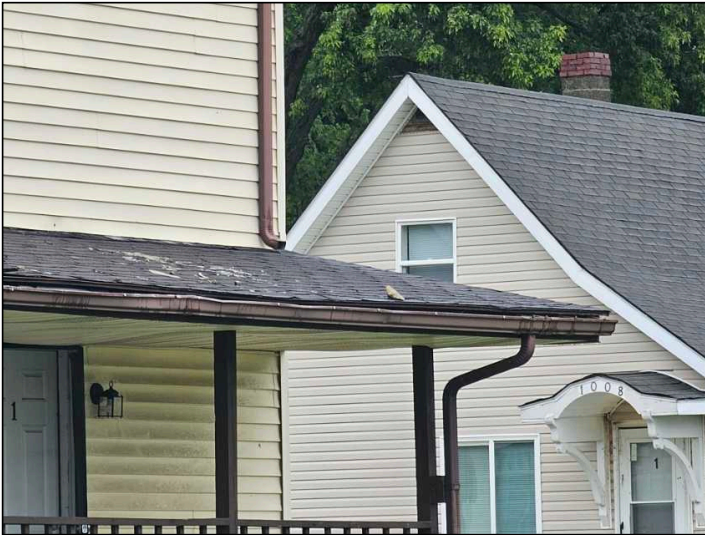
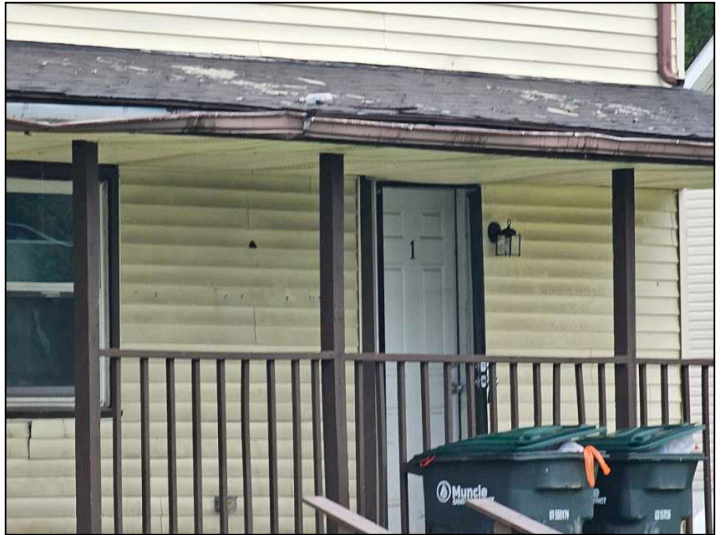
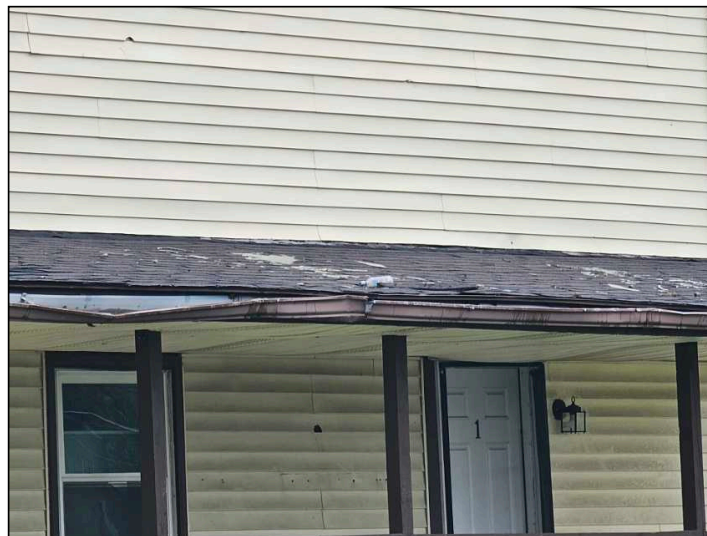
- Some shingles damaged.
- Serviceability of roof is questionable; it should be evaluated and repaired as necessary by a professional roofing contractor.
- Note that experts recommend that any roof over 10 years old receive a roof certification by a local roofing specialist.

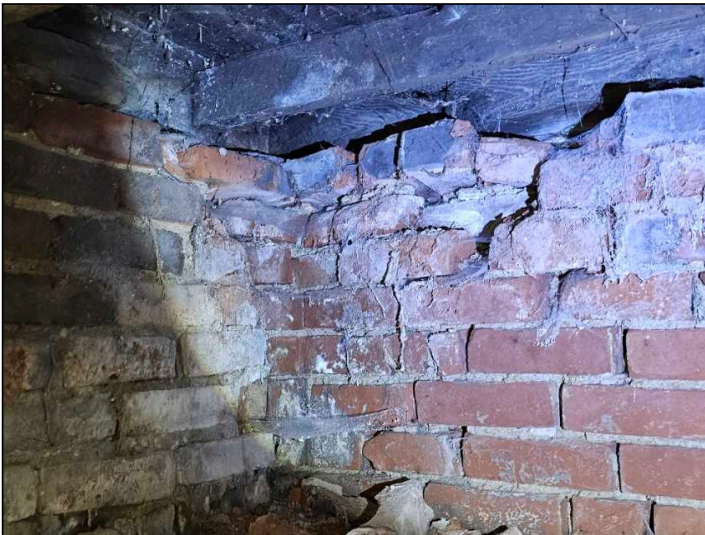
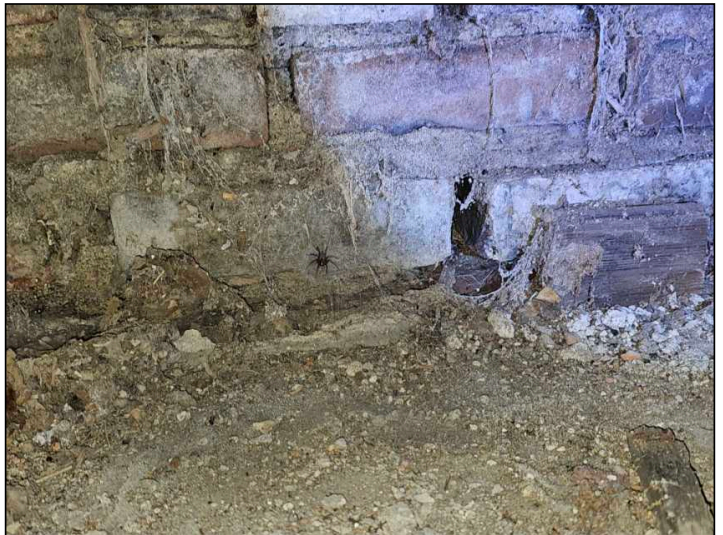
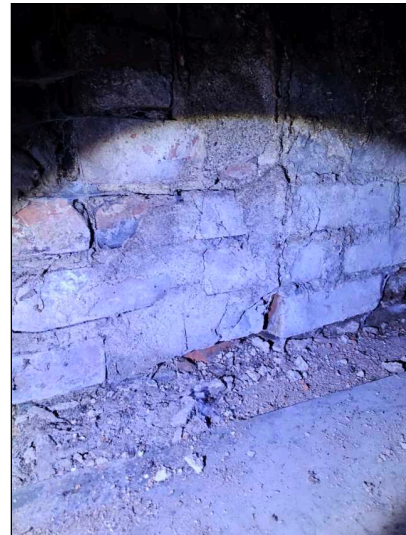
- It had rained heavily the day before and was misting at the time of inspection. Recommend having a licensed plumber
- Visible portions of foundation wall were dry at the time of the inspection.
- Large cracks were observed at the visible foundation walls. Repairs can be expensive and further settling or damage could occur. Recommend a Structural Engineer to provide a detailed analysis.
- The mortar in the brick foundation walls is deteriorating. Recommend further evaluation by a structural engineer.

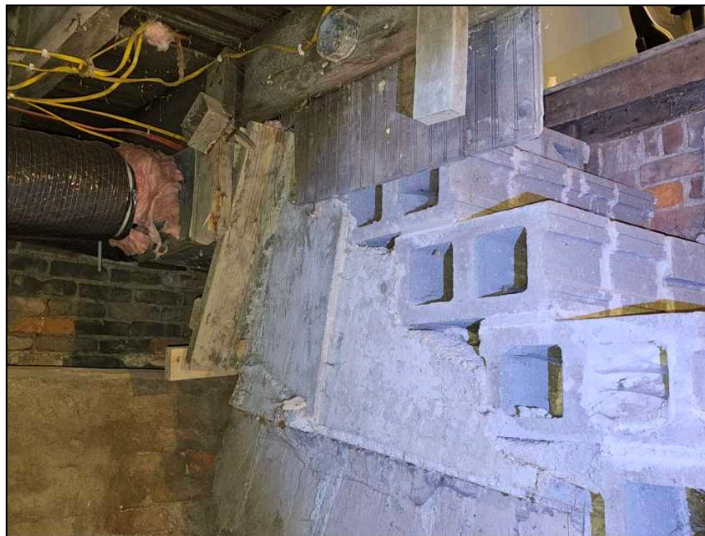
- Recommend review by a qualified professional for repair or replacement as necessary.
- Stairs have inadequate headroom, this is a safety concern.
- Unprofessional building practice/materials used, further review by a Qualified Contractor is recommended.

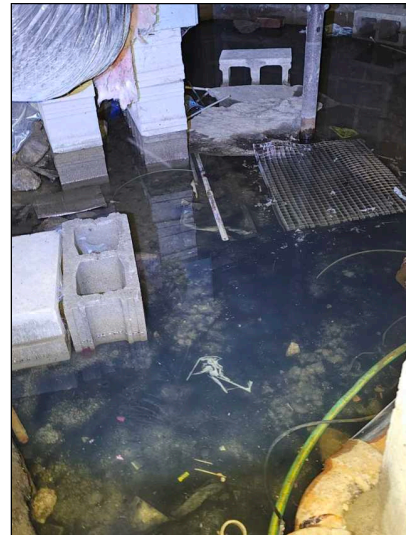
- Standing water noted on slab at time on inspection, review and repair needed to prevent possible water damage.
- Majority of the basement was inaccessible. Recommend a foundation specialist further evaluate the basement floor and walls once the standing water issue is resolved.

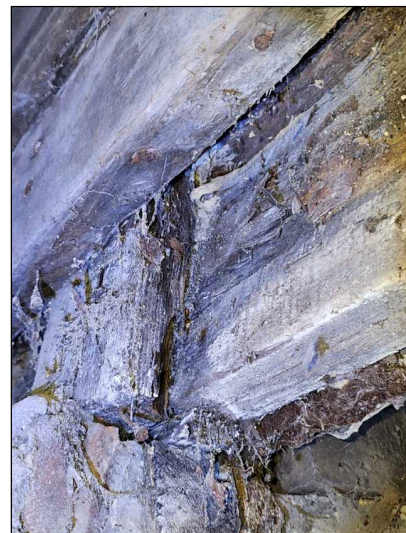
- **\*\*JOISTS\*\***
- Deterioration/ damage of one or more floor joist noted. Recommend review and repair by a Qualified Contractor to evaluate load bearing members.
- Recommend review of floor support system by a qualified contractor for any repair or upgrades needed to structure.
- Not fully visible for inspection due to lack of access to all areas.

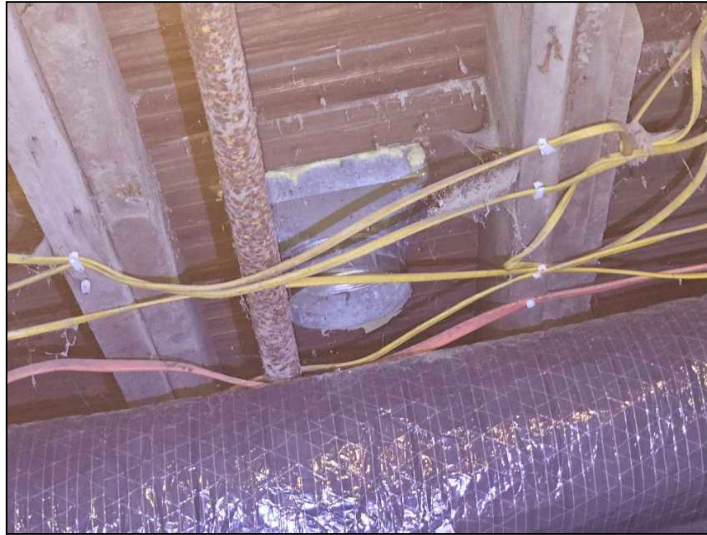
- Due to most of the basement being inaccessible the heating and cooling duct system needs reviewed and repaired as necessary by a Qualified Contractor.
- Unconnected ductwork noted in the basement.
