# *Complete Home Inspections LLC*

## Property Inspection Report

1001 W 1st St., Muncie, IN 47305

Inspection prepared for: Costas Themis

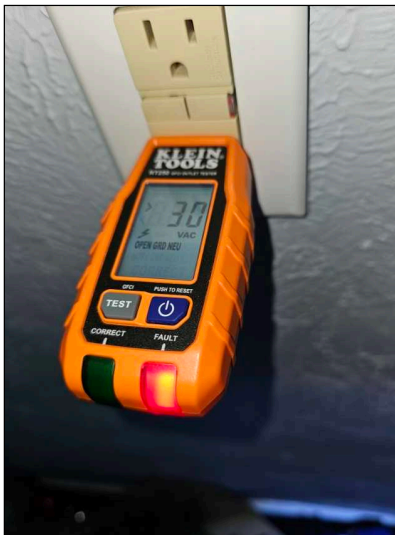
- Some outlets not accessible due to furniture and or stored personal items.
- **GFCI** outlet near the water heater was found to have an open ground/neutral fault when tested. This is an electrical shock hazard. Recommend repair by a licensed electrician.

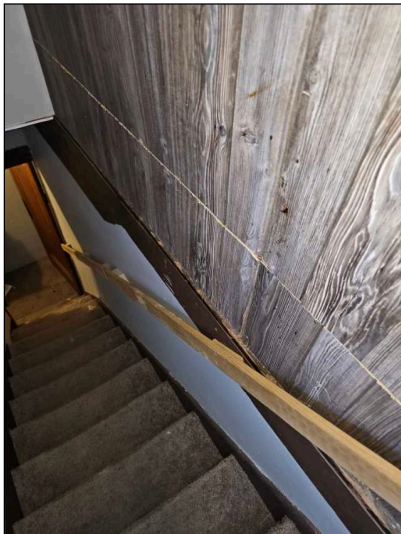
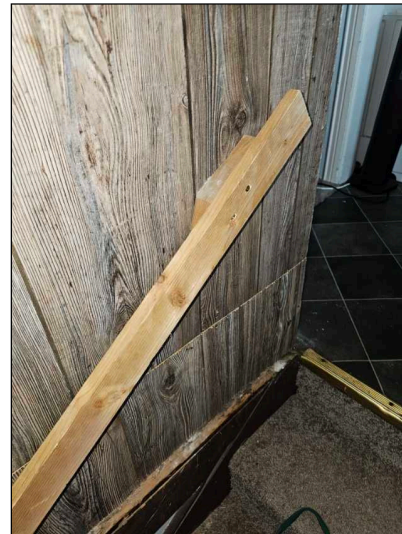
- Handrail is not 1.5 inches from wall.
- The riser and tread depth is not the same for each step and low ceiling height present a safety hazard. Recommend further evaluation by a qualified contractor.
- Makeshift handrail installed in unit #2 stairway. Safety hazard. Recommend installing a proper handrail by a qualified contractor.

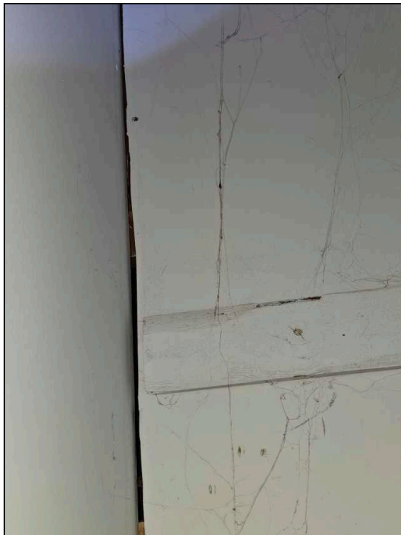
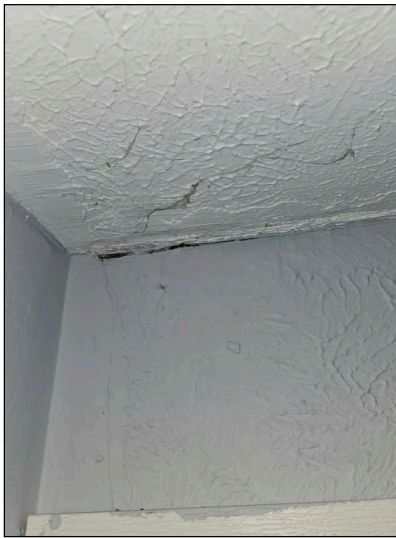
- There were several areas that were unfinished or had minor deterioration of the plaster ceilings. No active leaks observed at the time of the inspection. Recommend further evaluation by a qualified contractor.

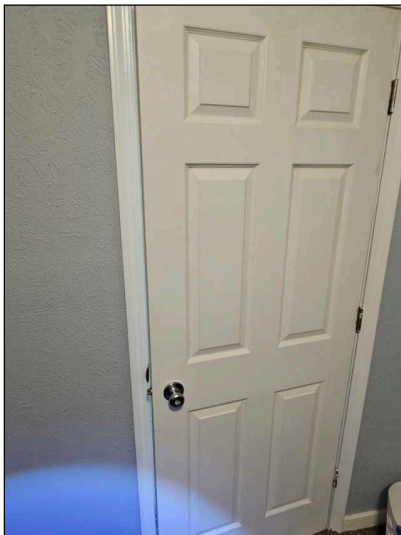
- Issues with operating every door in the house. Tight fitting. Difficult to open and close or does not latch properly. Recommend repair by a qualified contractor.

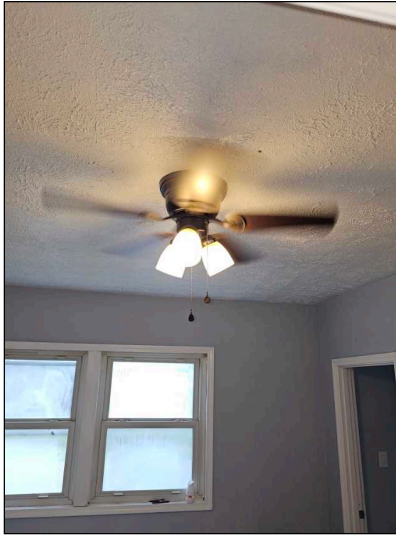
• One or more bedroom window/s shows sign of loss of seal/condensation, recommend repair or replace for energy efficiency.

• Most of the operated windows appeared functional, at time of inspection but due to exterior conditions it is recommended to have the windows further evaluated by a qualified window contractor.

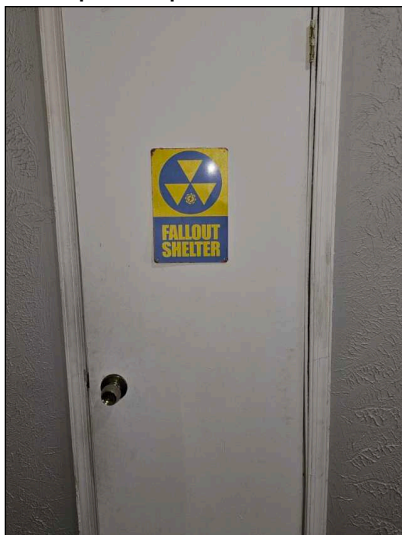
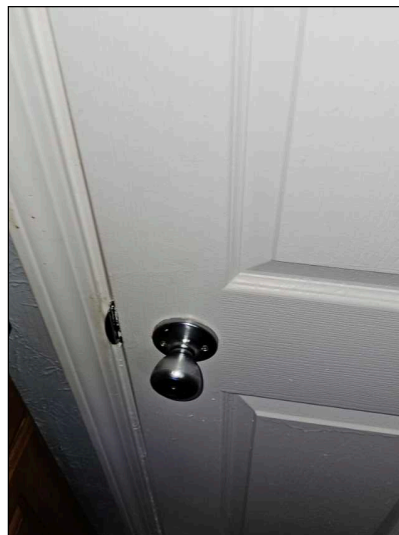
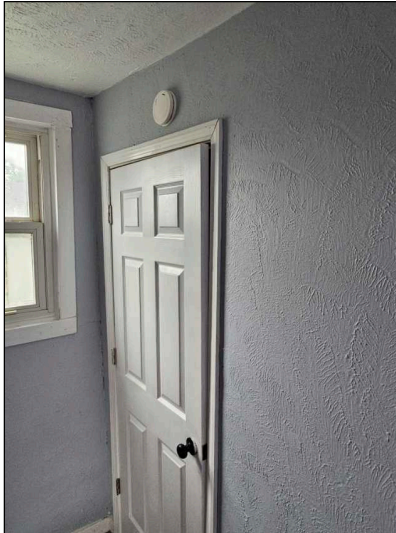
- Door doesn't latch properly.
- Door binds in jamb or floor.
- Majority of doors in the house do not close or latch properly. Recommend repair/replacement as needed by a qualified contractor.

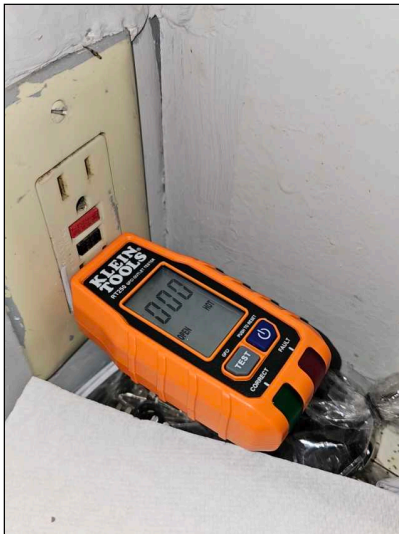
- GFCI outlet in the bathroom of unit #2 was not functional. No power indicated when tested and would not reset. Recommend replacement by a licensed electrician.
- GFCI outlet in the bathroom for unit #1 was found to have an open ground fault when tested. Recommend a licensed electrician to repair the issue.

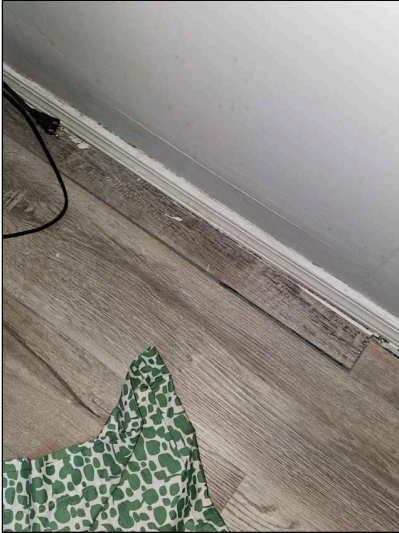
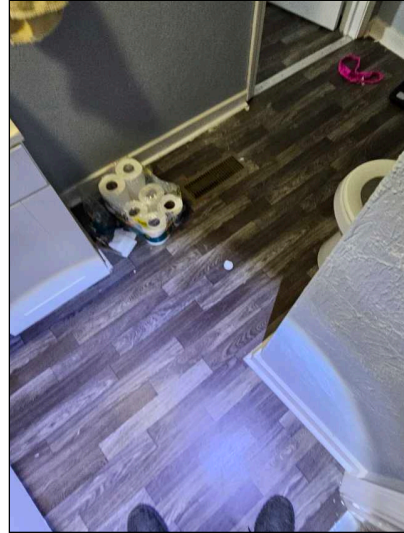
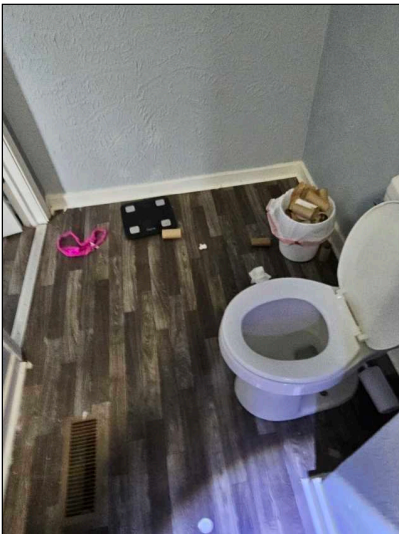
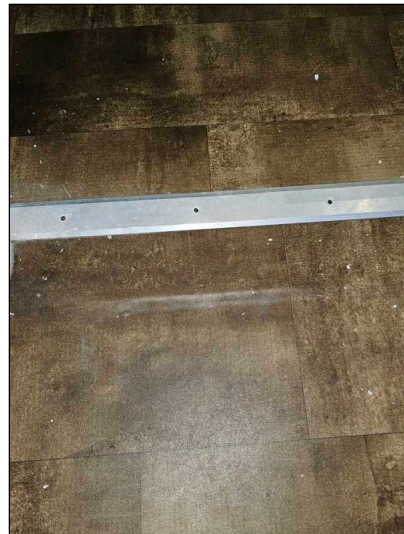
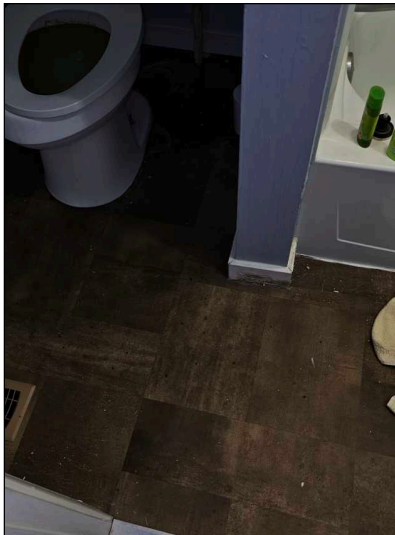
- Laminate floating floor system in unit #2 bathroom was installed with poor workmanship techniques, gaps are visible giving a less than appealing appearance and likely lowering the serviceable life of the flooring. Recommend monitoring for deterioration due to it being in an area with excess moisture.
- Vinyl flooring is rippled in the bathrooms of unit #1. Possible tripping hazard and could cause premature wear of the material. Recommend monitoring and replacing as necessary by a qualified contractor.
- Recommend review for repair or replacement as necessary.

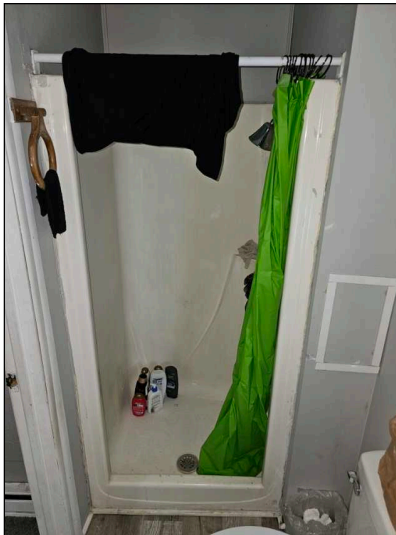
- **\*\*MATERIALS\*\***
- Fiberglass surround noted.
- **\*\*OBSERVATIONS\*\***
- Recommend caulking as required.

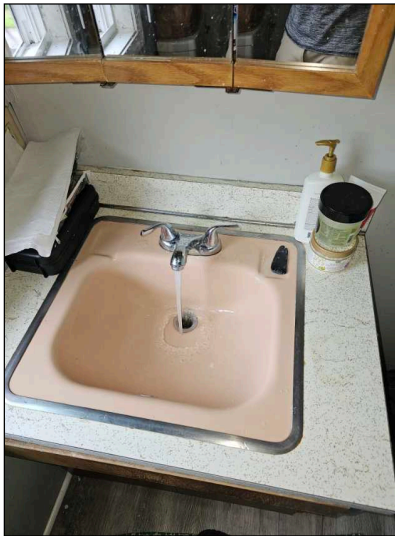
- **\*\*DRAINS\*\***
- No issues were observed with the sink drain at the time of inspection.
- **\*\*SUPPLY\*\***
- Operated normally, at time of inspection.
- Sink in unit #2 bathroom was functional at the time of inspection but is most likely beyond its normal life expectancy. Recommend considering replacement by a qualified contractor and licensed plumber.

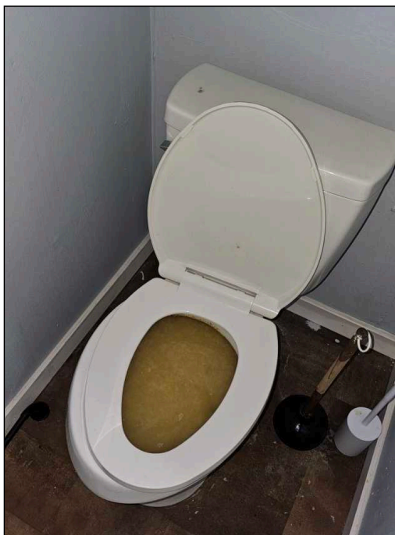
- Toilet in Unit #1 bathroom off of the kitchen was clogged and would not drain. Recommend further evaluation by a licensed plumber.

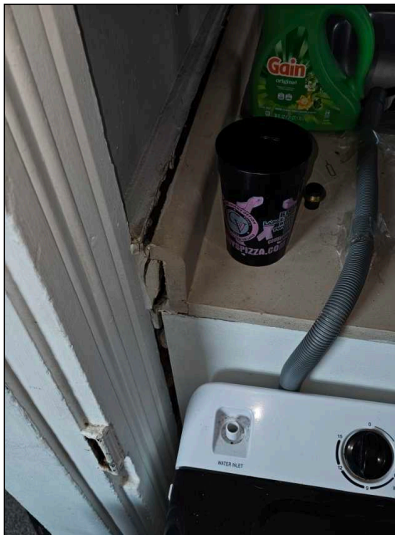
- Cabinets appeared to be beyond the expected lifespan. Consider upgrading
- Some cabinet doors need magnets or hardware to stay shut. Repair as needed.
- Some cabinet drawers need hardware repair/adjustment (to stay shut). Repair as needed.

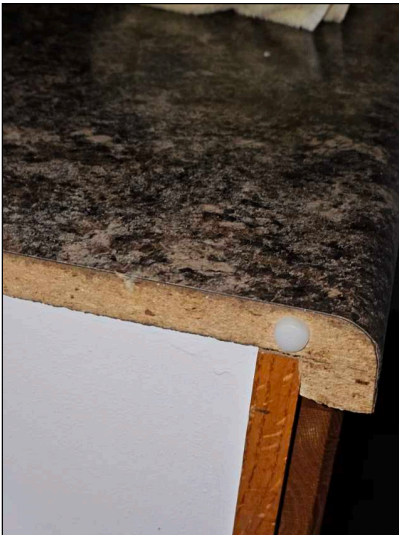
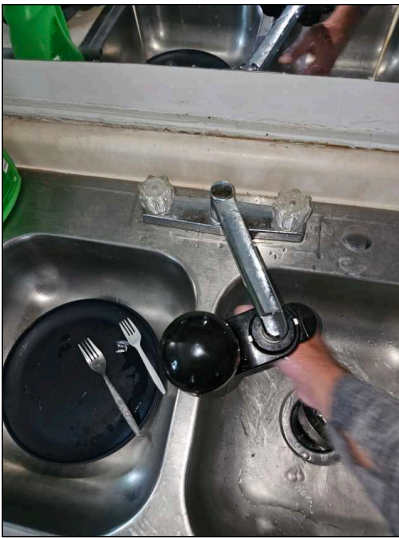
- Plastic laminate tops noted.
- Particle wood exposed on edge of the countertop in the kitchen of unit #1. This makes the countertop susceptible to moisture damage. Recommend repair by a qualified contractor.
- Countertop in the kitchen of unit #2 appears to be beyond the expected life span of the material. Recommend considering new cabinets and countertop.

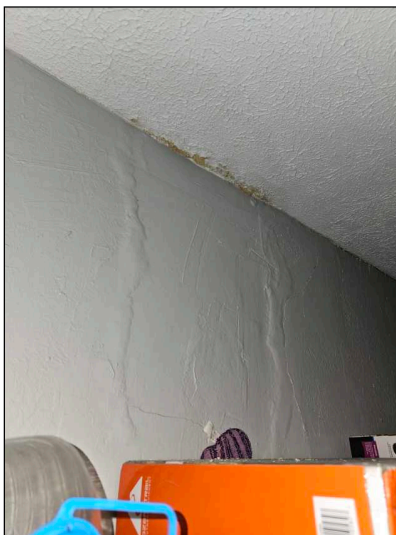
- Minor damage noted from what appears to be from excess moisture in the kitchen area of unit #2. No active leaks were observed at the time of inspection. This area was also near the chimney in the attic. Water damage may be from poorly installed and missing flashing around the chimney on the roof. Recommend further evaluation by a qualified contractor.

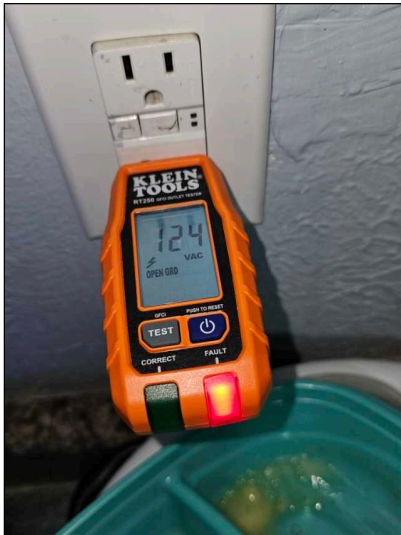
- Not all outlets in the kitchen were GFCI protected. While it may not have been required when the house was built. We suggest buyer consider upgrading with GFCI's at all receptacles near water sources.
- GFCI tested and found to be improperly wired. Potential shock hazard in a high moisture area. Recommend review and repair by a licensed electrician.

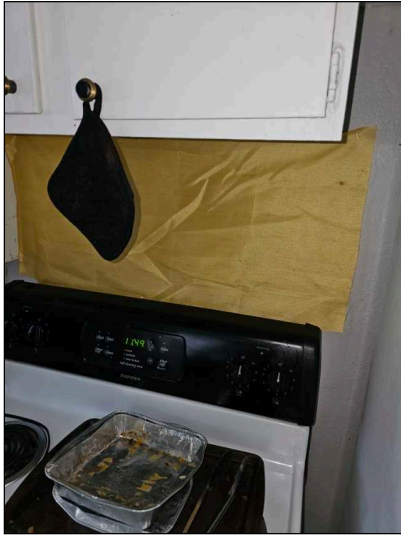
- Limited review due to storage of personal property and finished walls.
- There is evidence of moisture entering structure in the kitchen in unit #2. We recommend contacting a contractor experienced in exterior systems to evaluate the area and suggest repair options.
- Paper covering wall above stove is possible obstructing damage to the wall.

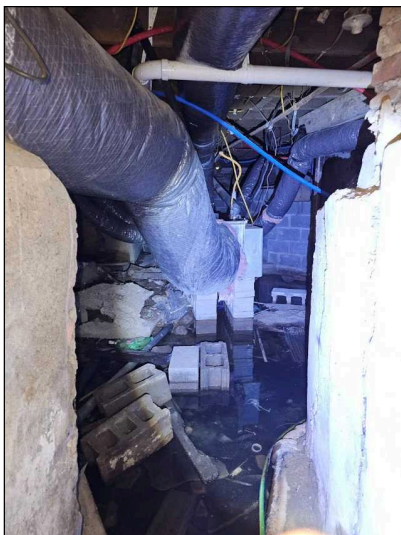
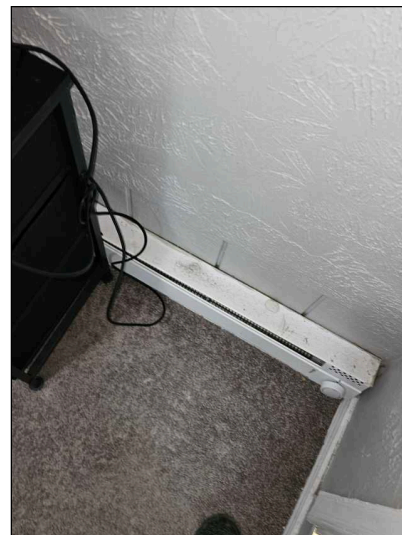
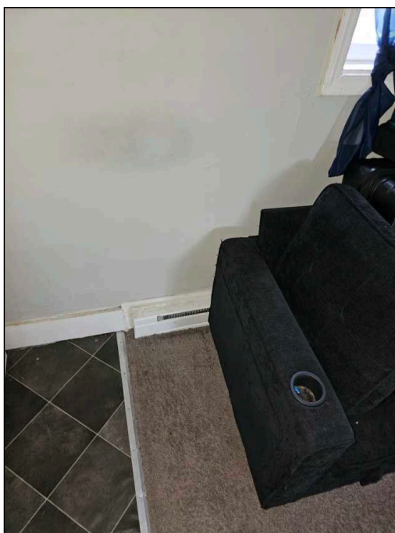
- The furnace could not be inspected due to outside temperature and standing water in the basement. Recommend having the heating system further evaluated by a licensed HVAC contractor when the water issue is resolved.

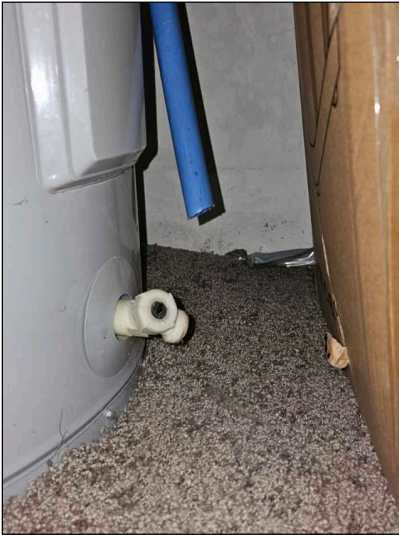
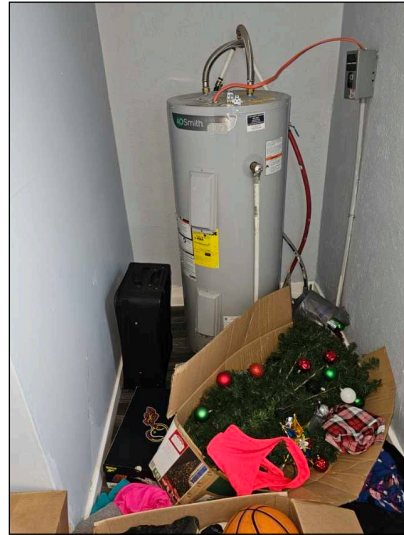
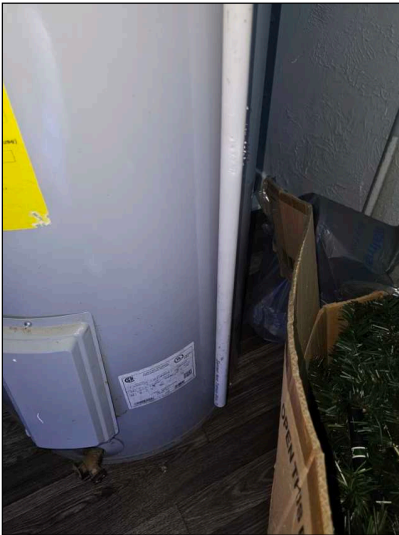
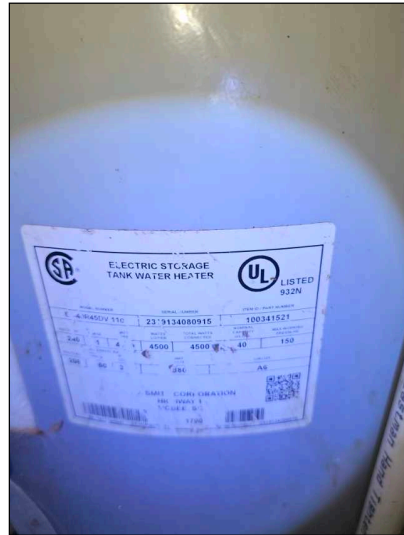
- The water heater bases appeared functional at the time of inspection.

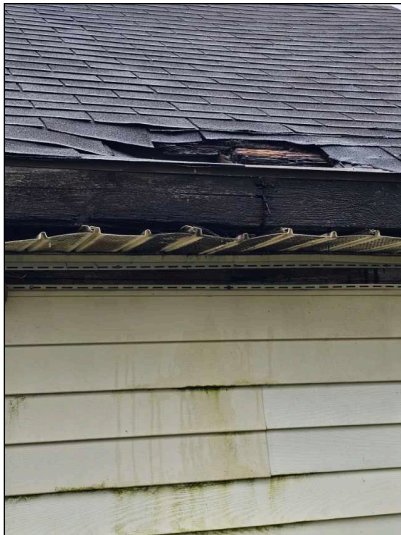
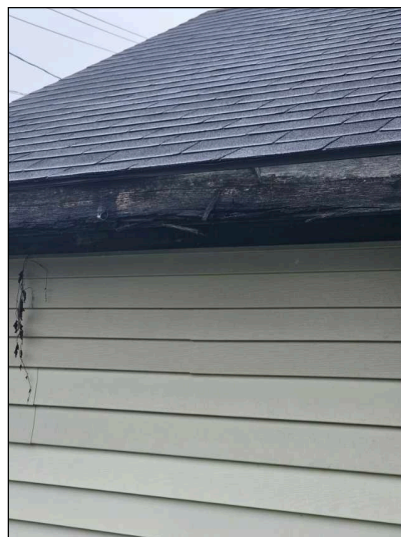
- Some shingles and/or tabs missing.
- Some shingles damaged.
- Roof sheathing has been damaged.
- Indications of past or present water leaks, seeps, or condensation at eaves.
- Recommend further evaluation for repair/replacement by a qualified roofing contractor.
- Deterioration of exposed wood noted at the eaves around the garage. Recommend repair by a qualified siding contractor.

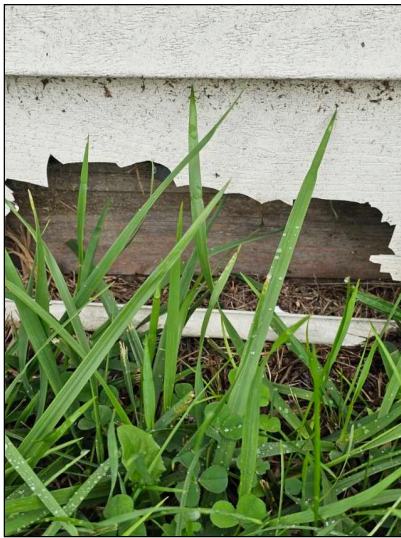
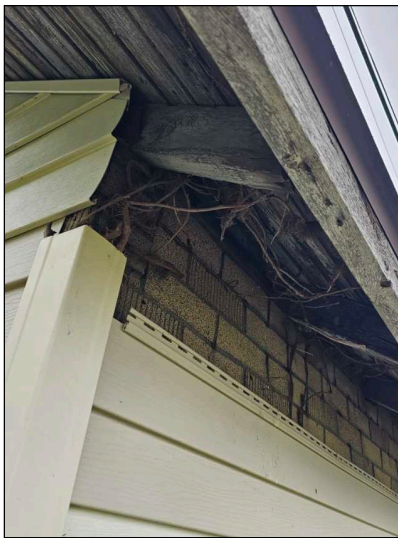
- The interior of the detached Garage/Shed could not be inspected due to restricted access. No key was available to unlock the exterior door at the time of inspection.
- Exterior siding is missing and damaged in multiple areas and is in close proximity to the ground. These issues can allow water damage to occur. Recommend repair/replacement by a qualified contractor.

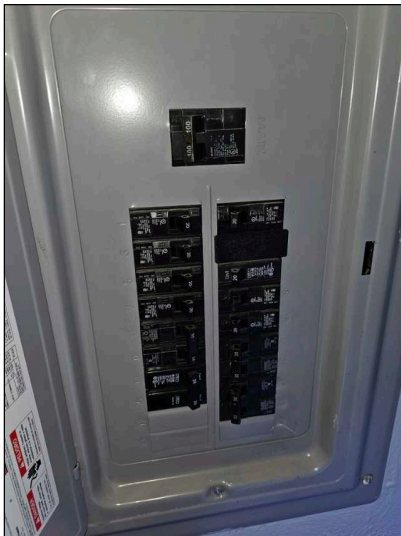
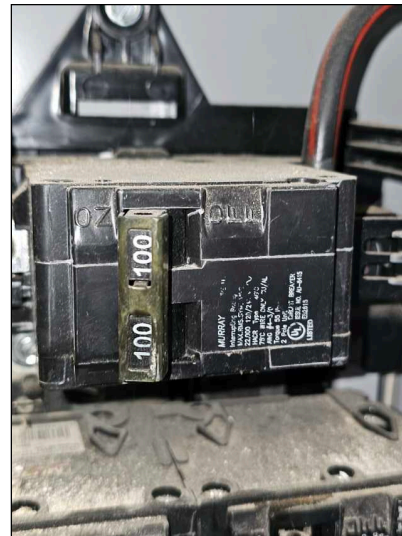
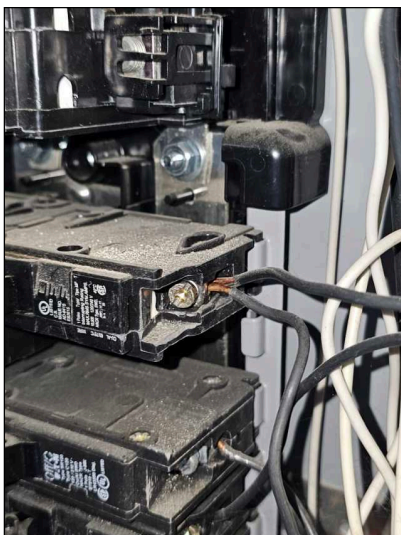
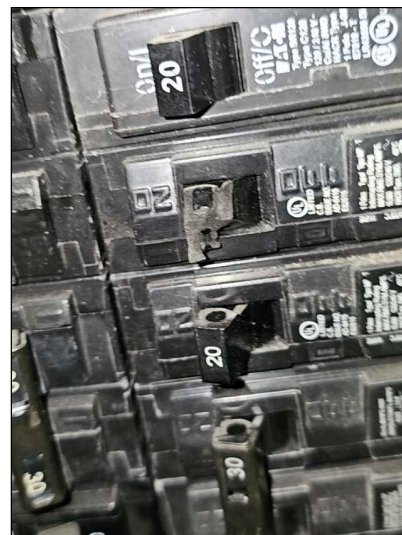
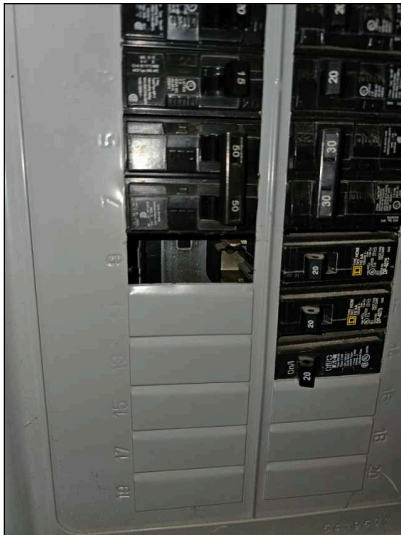
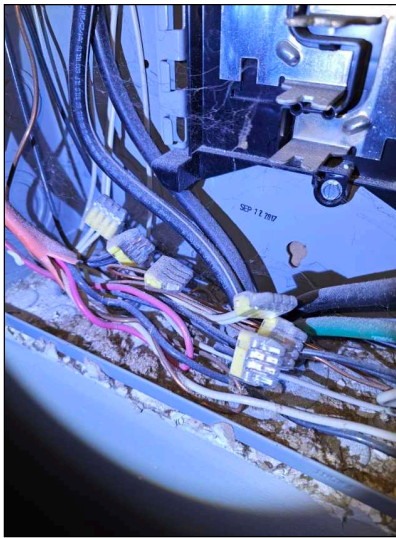
- Open breaker panel slot(s) at panel box cover in unit 2. Electrocution hazard. Recommend repair by a licensed electrician.

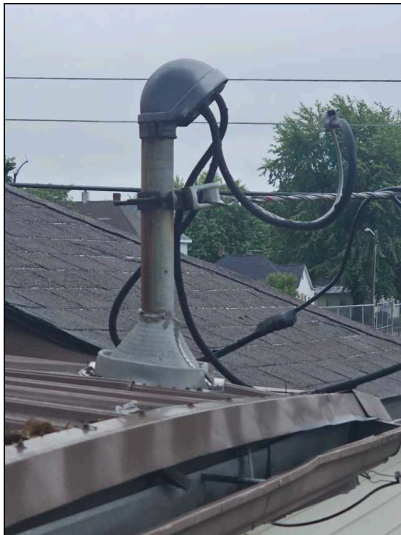
- There is an overhead service drop noted.
- The weather head is too low and the driploop is resting on the metal roof, this is a serious safety concern. Recommend review by a licensed electrician for repair or replacement, as necessary, prior to close.

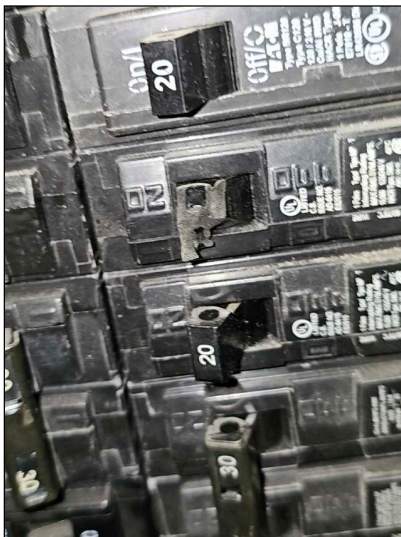
- All of the circuit breakers appeared serviceable in both units with exception of one breaker that had a broken switch in unit 1. Recommend replacement by a licensed electrician.
- Double tapping observed in unit #1. Double tapping (i.e. 2 wires on a single pole breaker) can add to the load of the affected circuit causing a possible overload and tripping breakers, or result in loose connections and overheating of the breaker or connections. Recommend further evaluation and repair by a licensed electrician

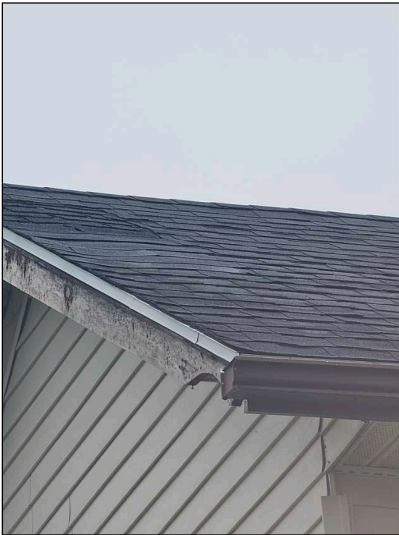
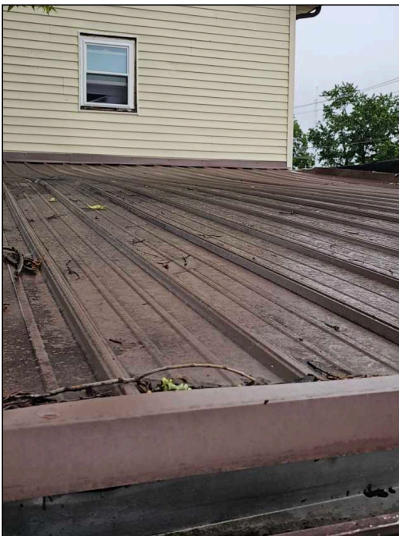
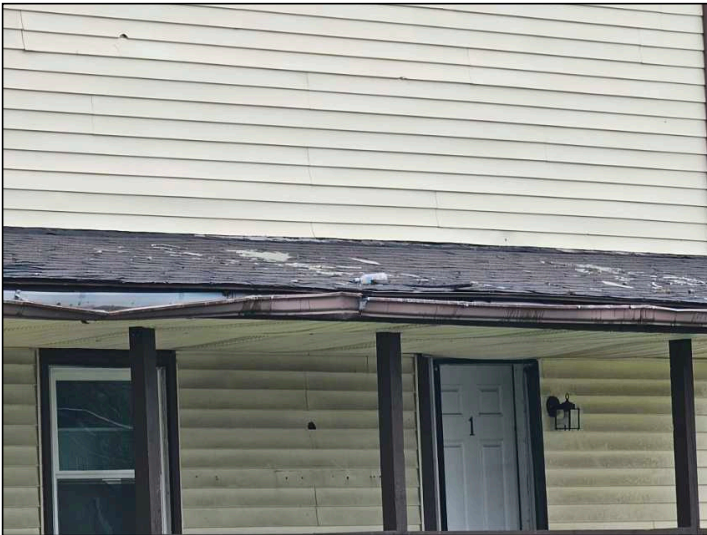
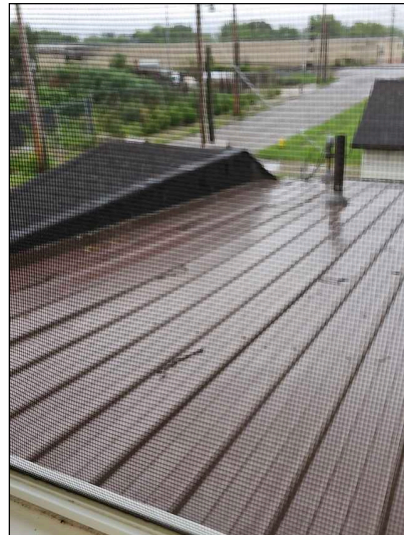
- Some shingles &/or tabs missing.
- Some shingles curling.
- Some shingles damaged.
- Recommend roofing contractor to evaluate.

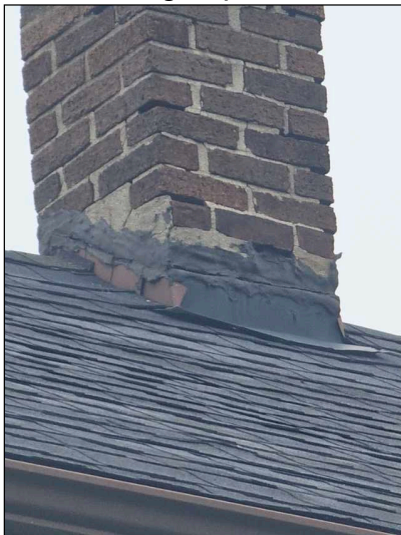
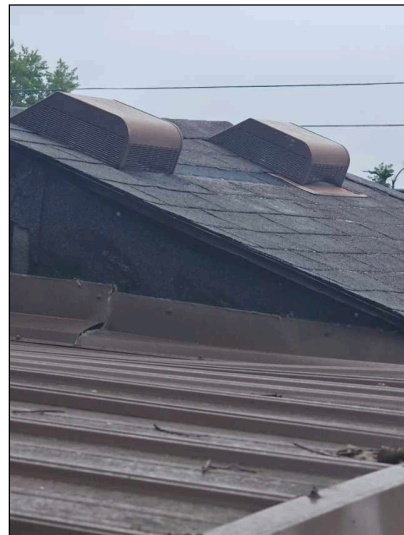
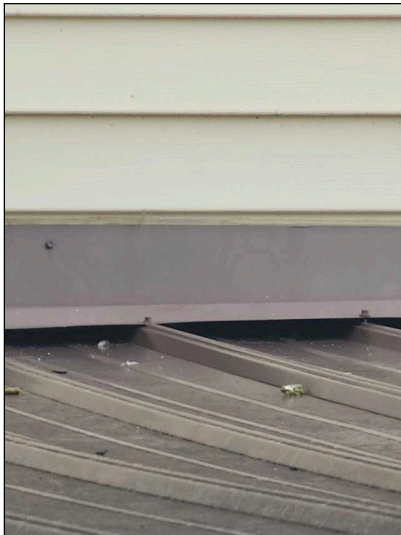
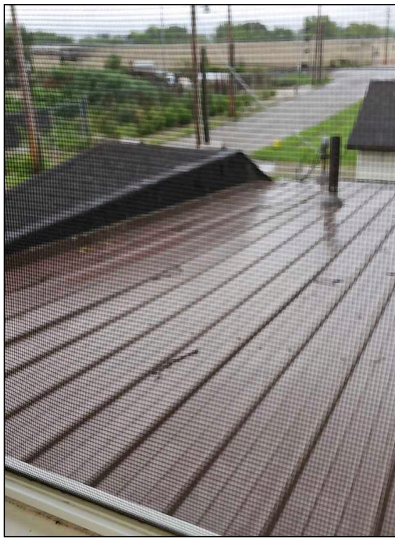
- Flashing is missing around the chimney. Recommend a qualified roofing contractor to further evaluate the roof.
- The caulking was deteriorating on the flashing around the metal roof. Recommend resealing to prevent leaks.

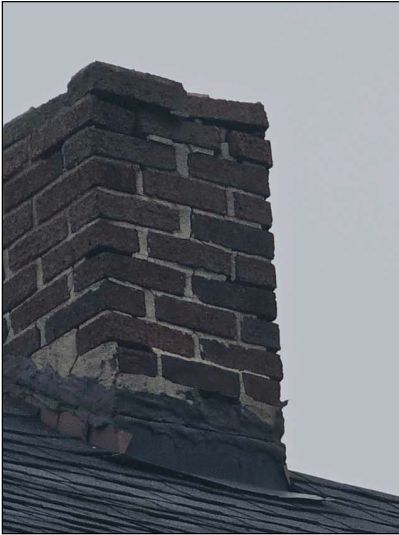
- No chimney cap visible from inspection level. Recommend installation to prevent weathering, water intrusion, and nesting of wildlife.
- Chimney Mortar shows sign of deterioration. Recommend having repaired as necessary.
- Brick and mortar deterioration observed; repair advised.

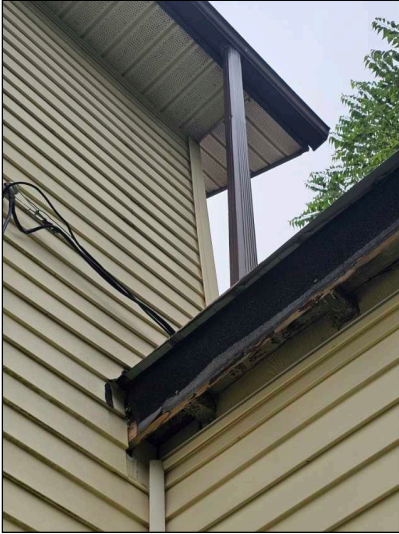
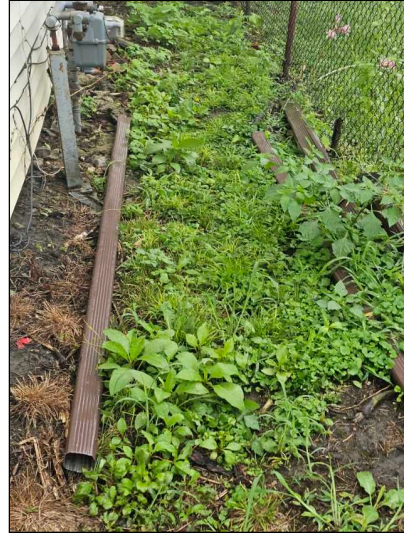
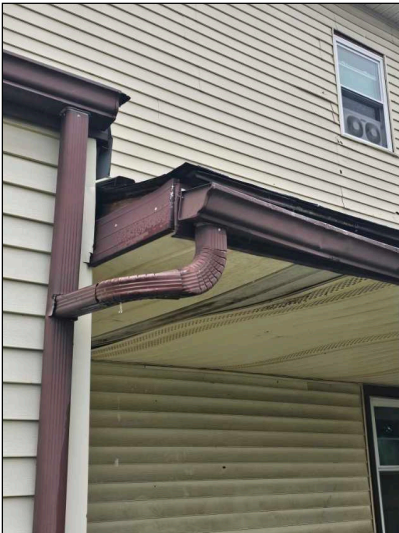
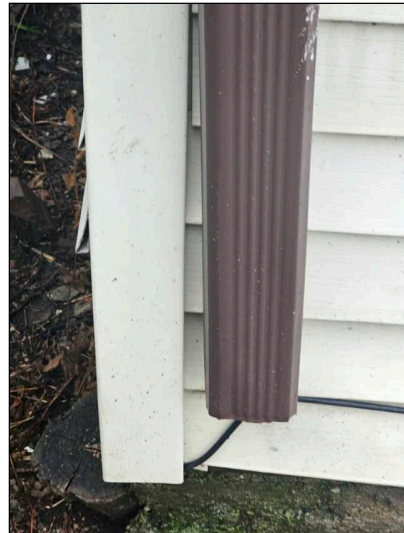
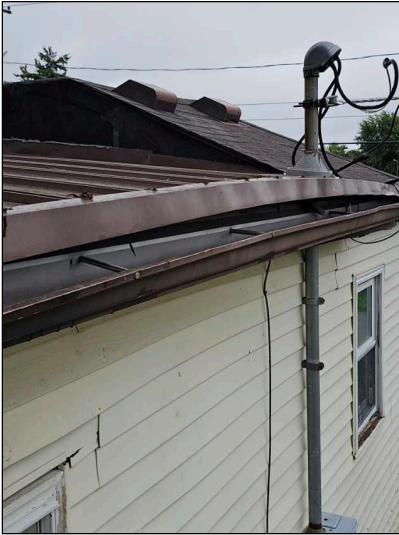
- The gutters were damaged or missing in multiple areas around the house. Recommend further review and repair/replacement as necessary by a qualified gutter company to keep water away from the foundation.
- Missing/fallen downspouts noted.
- Downspout on the south side of the house discharges straight down towards foundation. Suggest adding a splash block or extension.

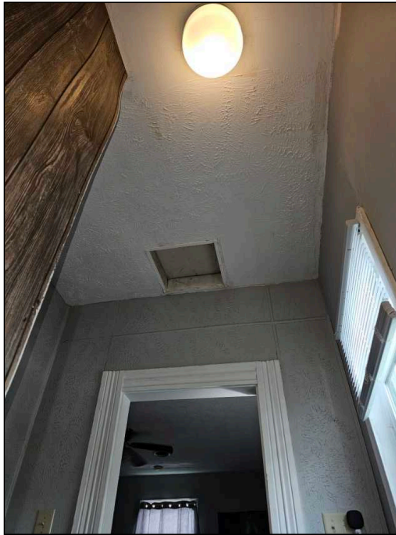
- \*\*Location of access\*\*
- Scuttle Hole located in the bedroom ceiling.
- Undersized or difficult to reach hatch making inspection limited.

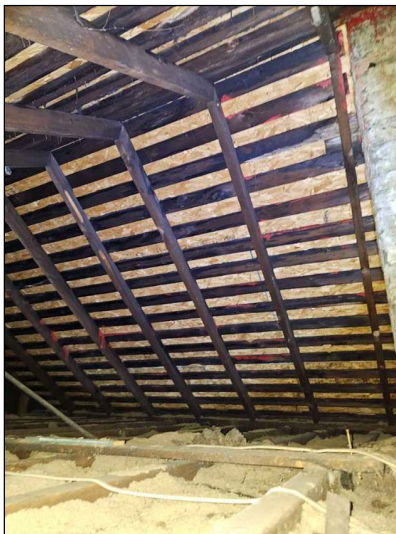
- Inspected from access hole only, limited space in attic prevented entry.

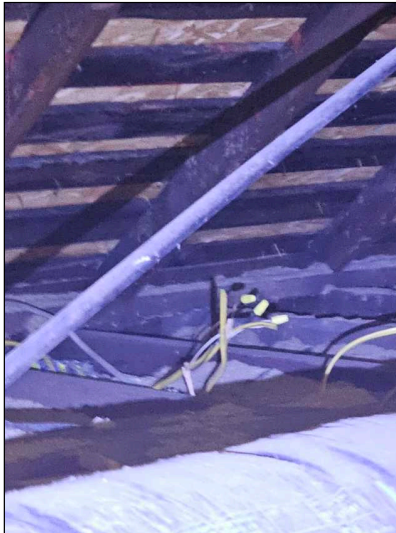
- Connections made outside of a Junction Box, which is a potential shock/fire hazard. Recommend repair by a licensed electrician.

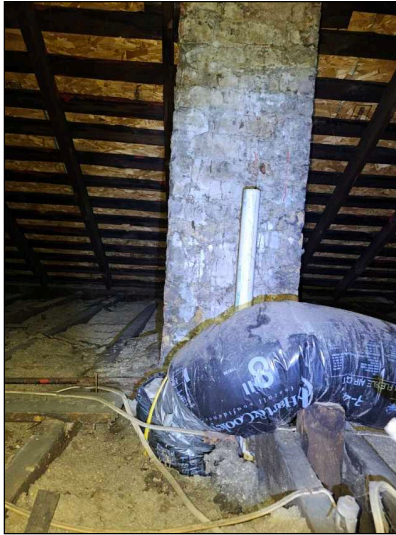
- PVC plumbing vent noted
- Vent pipe does not extend to the exterior of the house. Recommend repair by a licensed plumber.

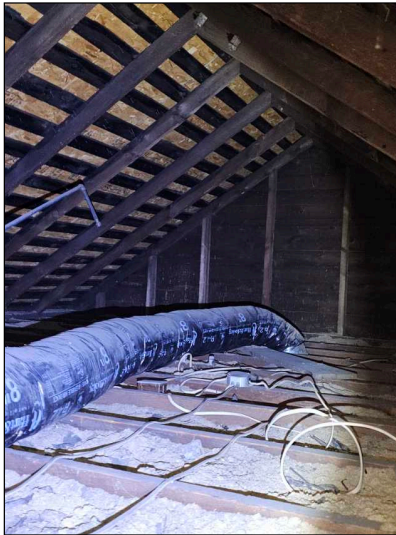
Depth: Insulation averages 3 to 4 inches. Recommend installing more.

- Insulation is sparse in some areas.
- Insulation that is settled does not perform to the R-Value that it once did.

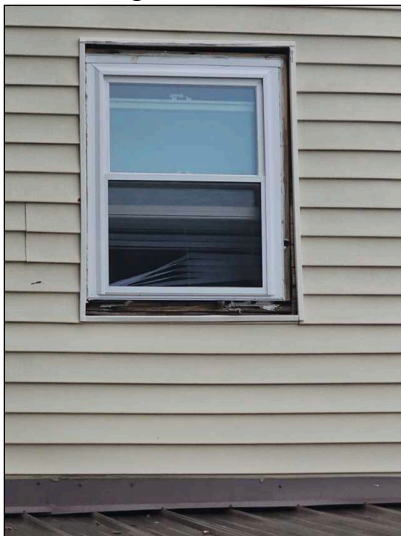
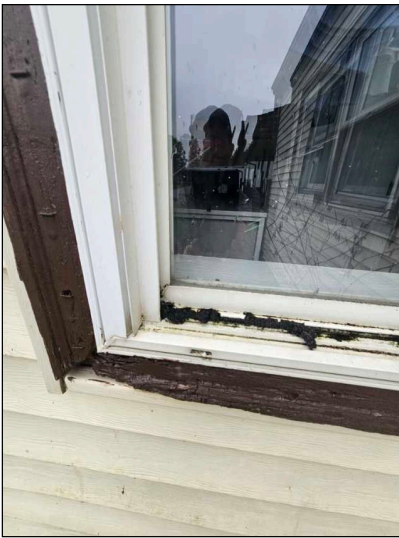
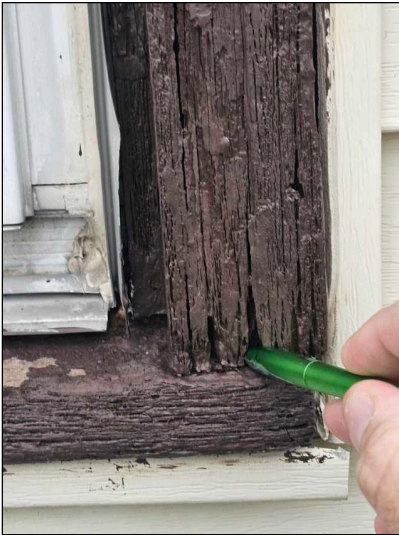
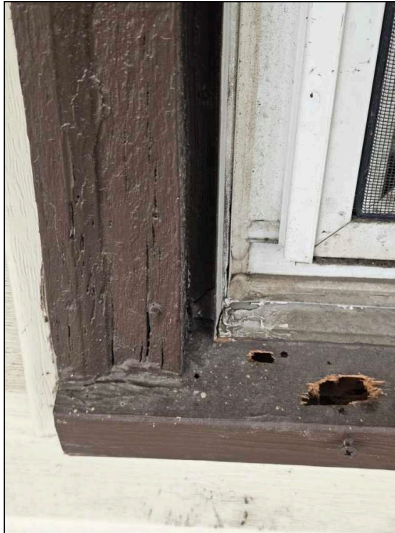
## 2. Window Condition

- Some window screens missing or damaged.
- Deteriorated exterior wood trim noted on several windows. Recommend repair/replacement by a qualified contractor.
- There is exposed wood around several of the windows. This can cause moisture damage. Recommend repair by a qualified siding contractor.

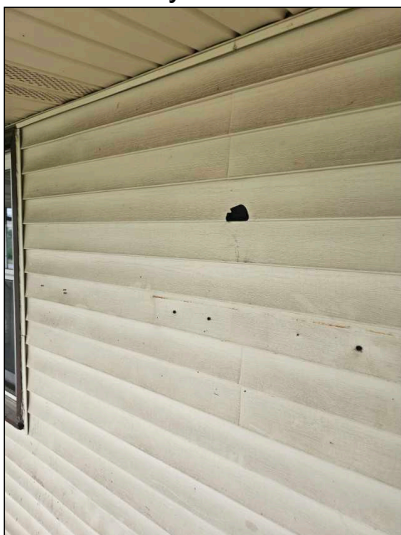
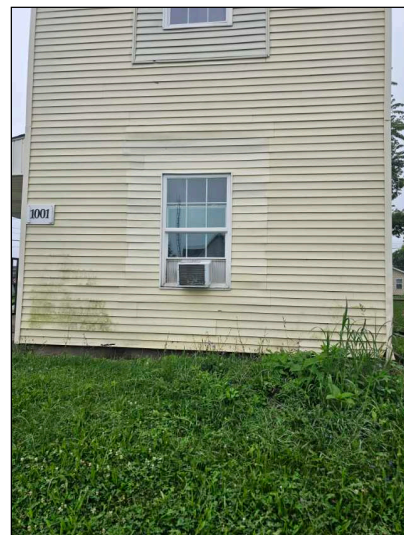
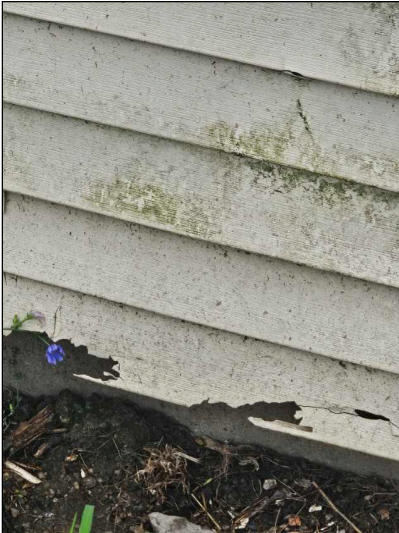
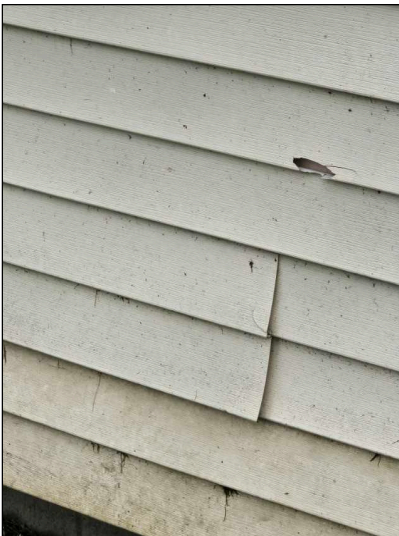
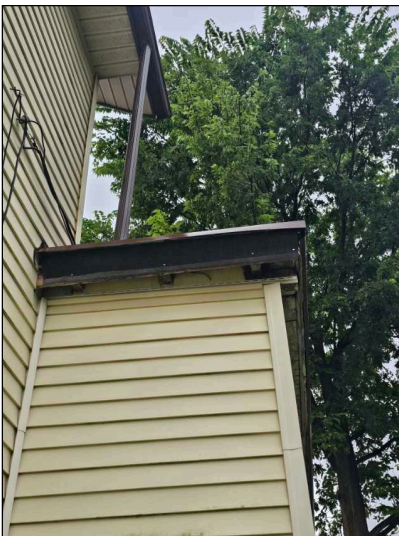
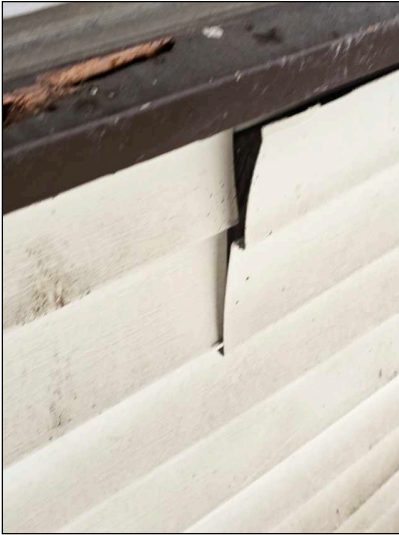
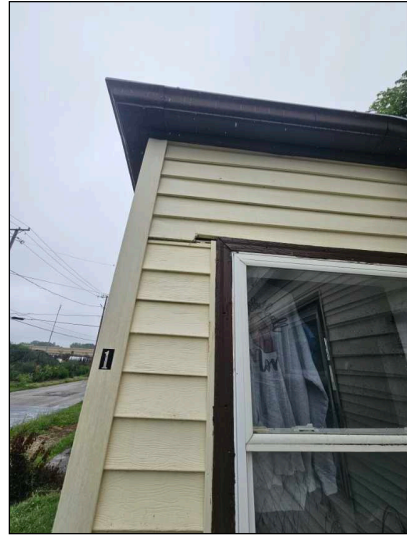
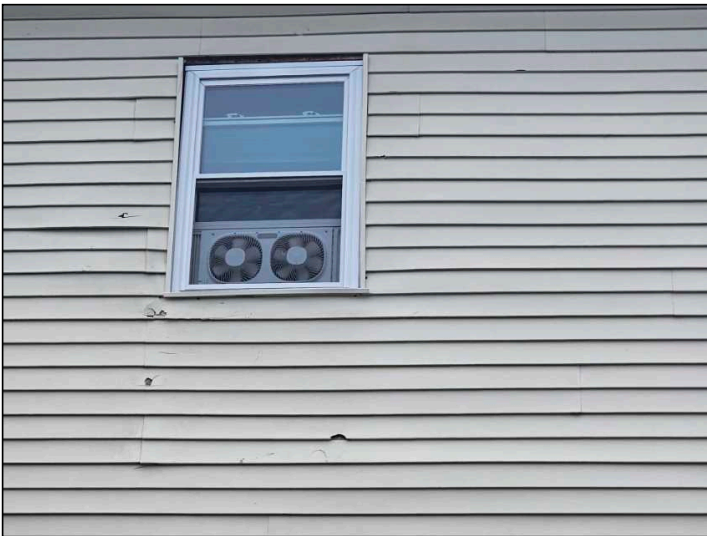
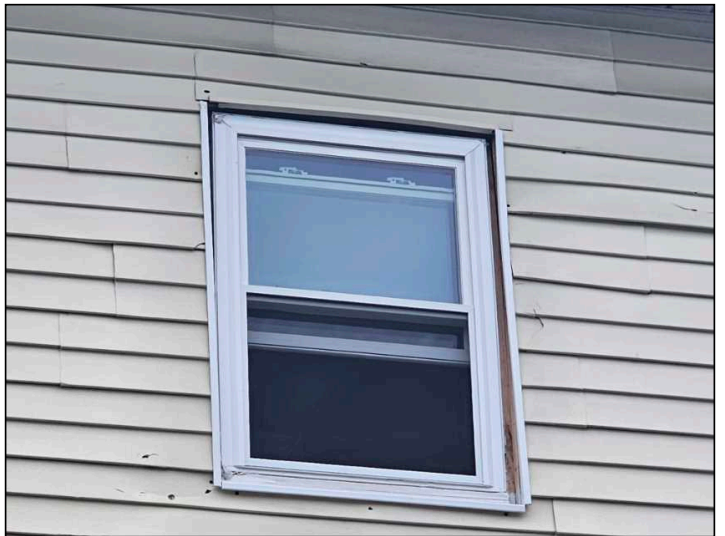
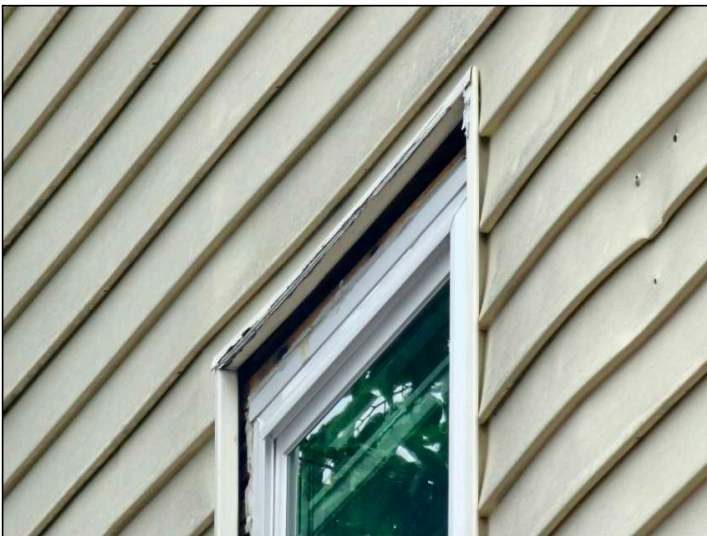
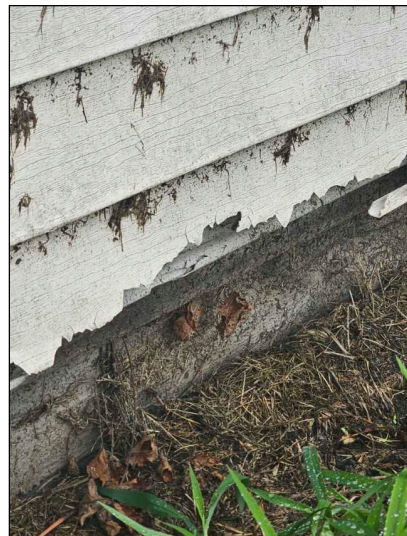
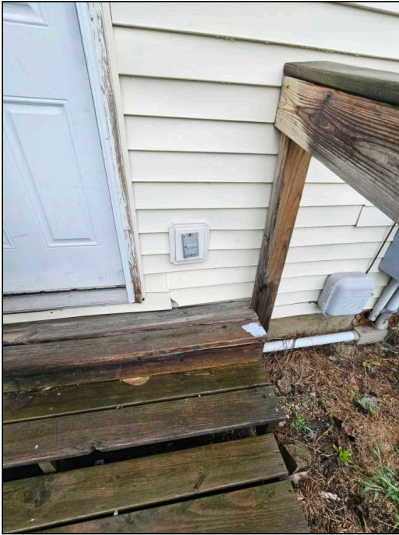
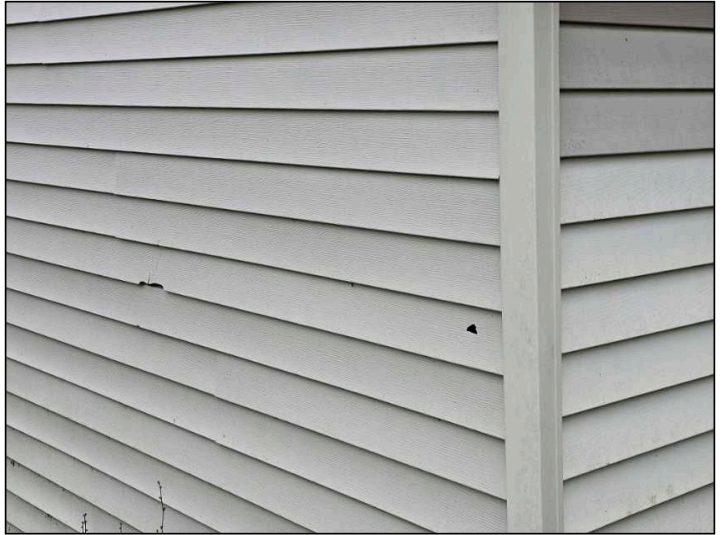
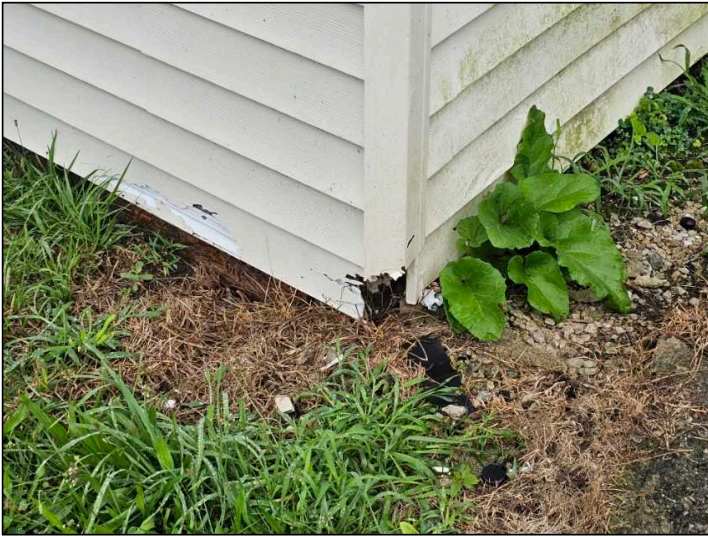
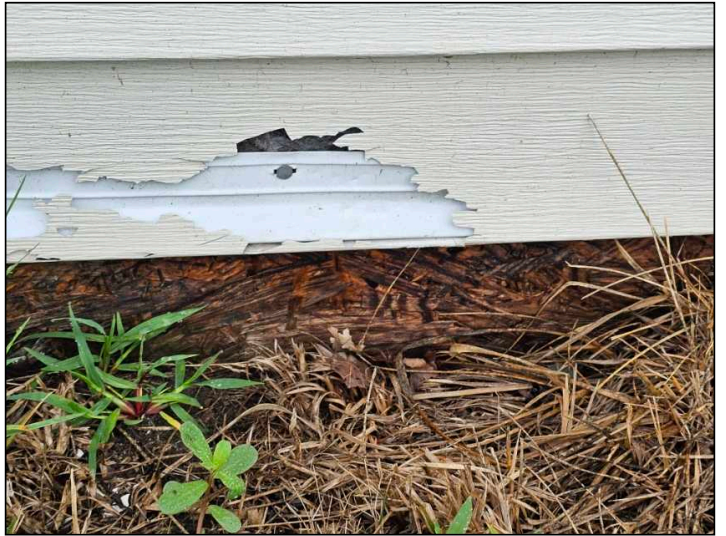
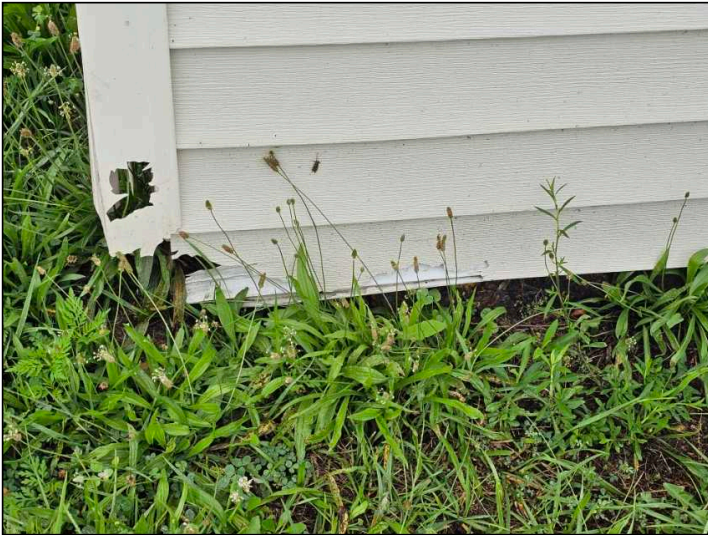
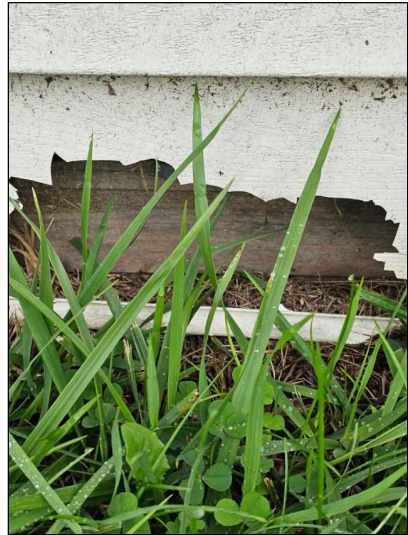
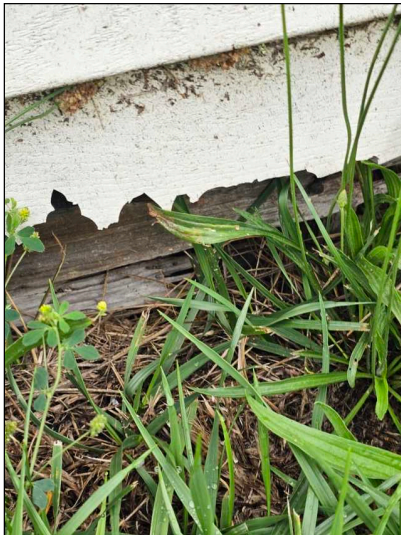
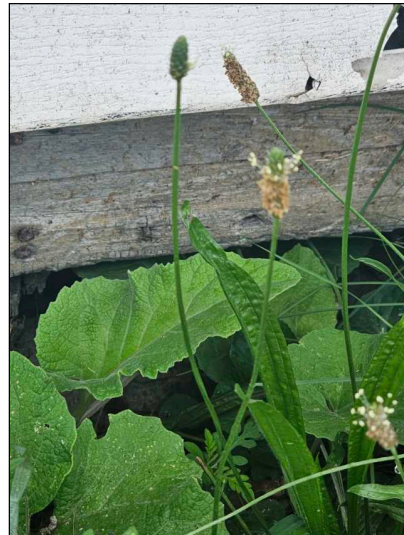
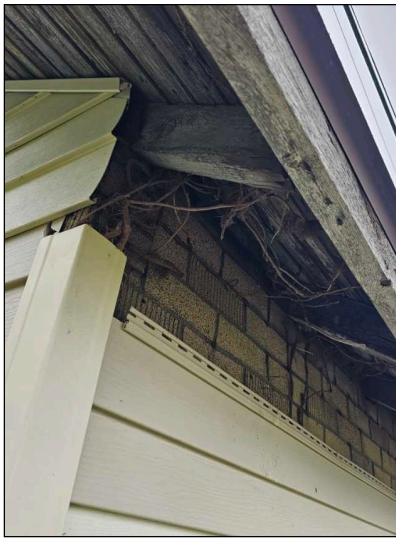
### 3. Siding Condition

- The siding is in close proximity to the soil. This may provide entrance for moisture or insects.
- Vinyl siding missing, damaged or improperly installed in multiple areas exposing the wood sheathing and can cause moisture damage. Recommend further evaluation by a qualified siding contractor.
- Warped siding present in some areas; recommend repair or replacement as necessary.
- Insect damage or activity suspected. Recommend further evaluation by a licensed exterminator.
- Some wood deterioration noted at garage - exterior personnel door frame base. Have repaired and inspected for wood-destroying insect damage.
- Moderate damage to vinyl: The vinyl siding covering exterior walls had areas of moderate damage which should be repaired to prevent moisture intrusion of the wall assembly.
