# *Complete Home Inspections LLC*

## Property Inspection Report

1001 W 1st St., Muncie, IN 47305

Inspection prepared for: Costas Themis

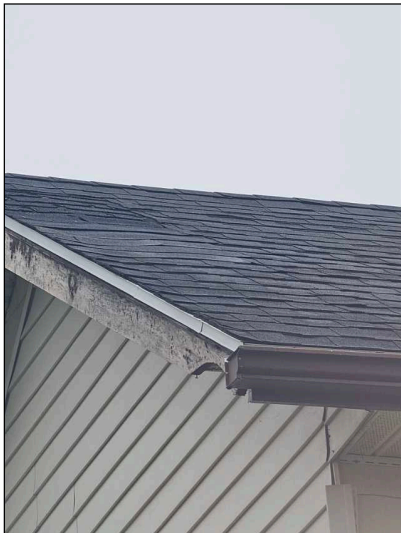
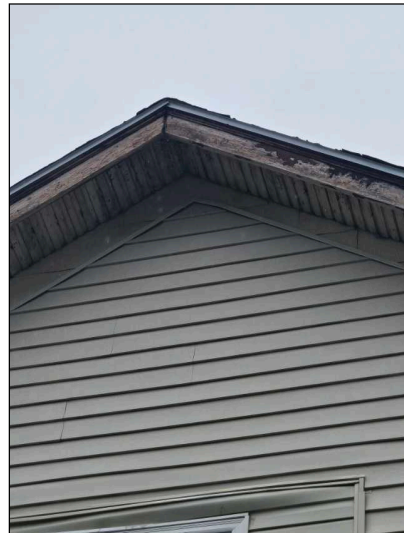
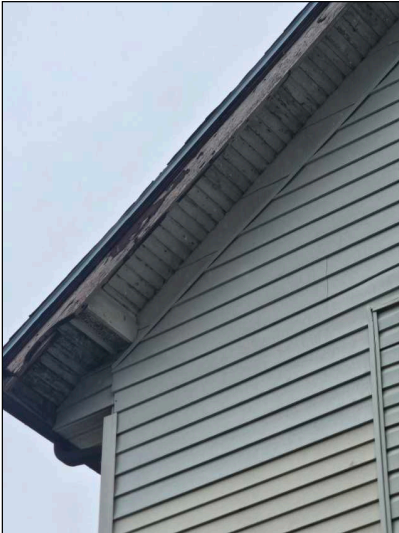
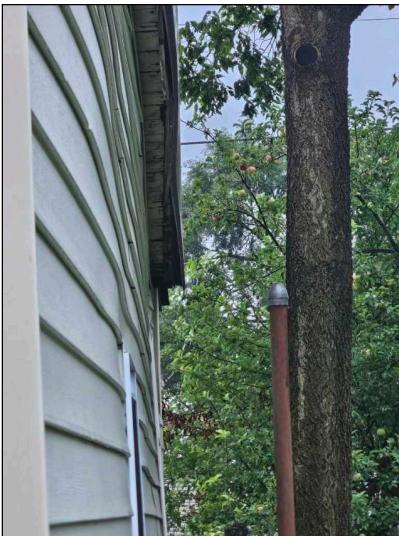
#### 4. Eaves & Facia

- In the inspectors opinion the trim is near the end of its useful life
- Moisture damage, wood rot, observed. Recommend review for repair as necessary by a qualified contractor.

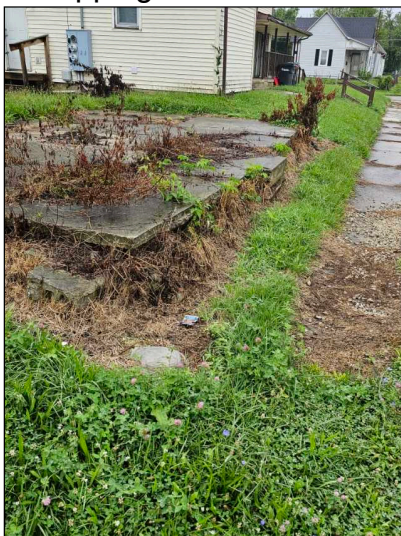
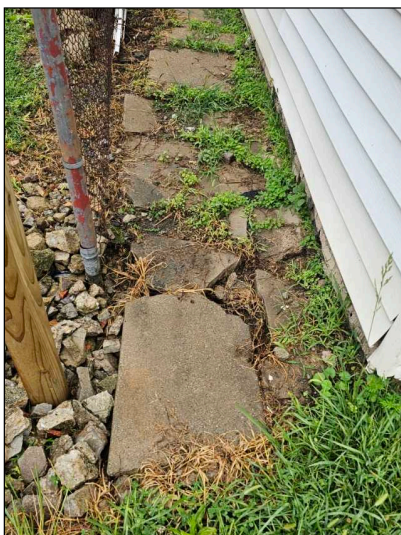
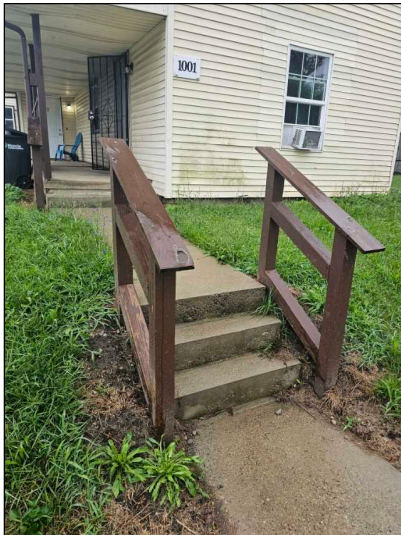
## 1. Driveway and Walkway Condition

- There are numerous areas of damaged concrete surfaces. Concrete replacement is expensive. Recommend a concrete specialist provide an estimate for repair and or replacing.
- Monitor: Surface deterioration observed at the concrete surface.
- Potential Trip/fall Hazard(s) at the sidewalk steps and old concrete pad located in the backyard; monitor/ repair as necessary.
- Handrail on sidewalk steps is no graspable by today's standards and is a potential fall hazard. Recommend a qualified contractor to replace handrails.
- Sidewalk along the garage/shed is severely deteriorated and is a potential tripping/fall hazard. Recommend repair by a qualified contractor.

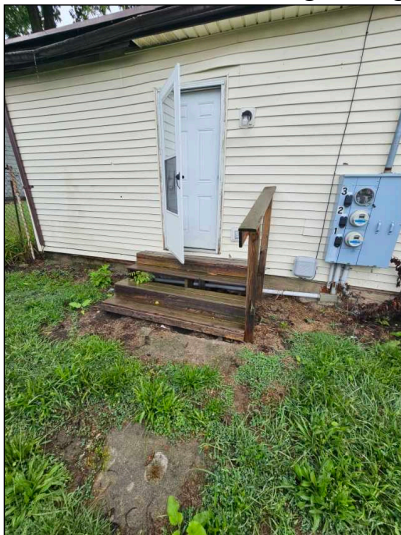
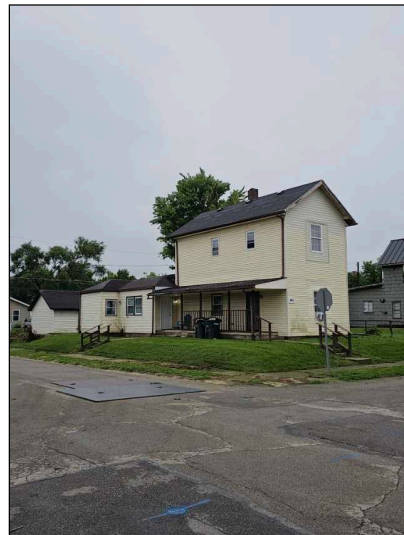
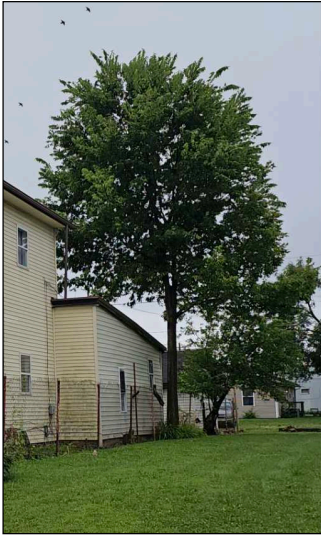
## 2. Grading

- The exterior drainage is generally away from foundation except on the west side of the house is flat. Evidence of moisture and organic growth present. Recommend further review by a qualified contractor.
- Low and settled grading was observed at north west corner. Fill as needed.

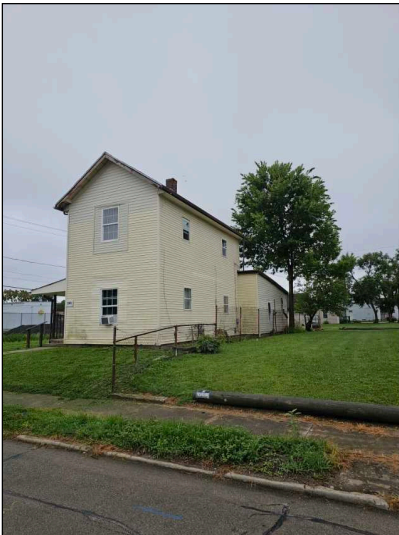
### 3. Vegetation Observations

- There is a tree on the neighboring property that is within 6 feet of house. Monitor for potential root damage to the foundation and possible damage to the roof from tree limbs.

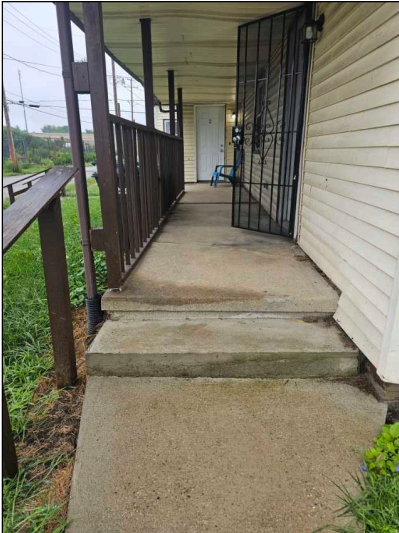
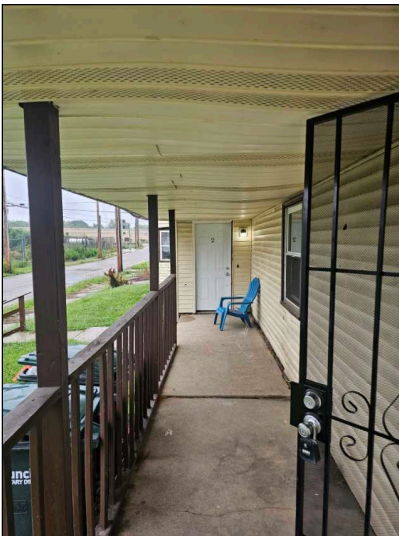
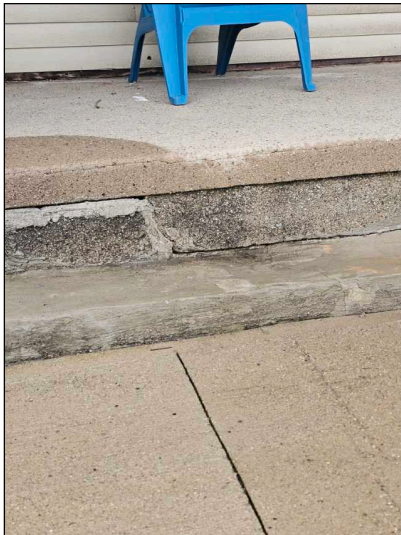
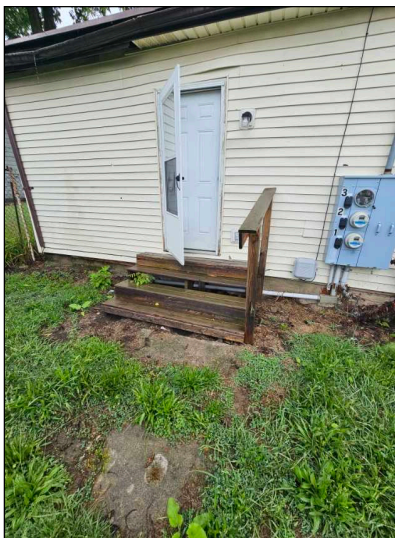
### 4. Patio and Porch Deck

- Balusters spaced to far apart.
- Non-conforming steps on the front patio, possible safety hazard.
- The steps are slanted on the back door of the downstairs unit and present a possible slipping hazard.
- Front concrete patio has a large settlement crack that caused the surface to be uneven. This is a potential tripping hazard. Recommend repair/replacement by a qualified contractor.

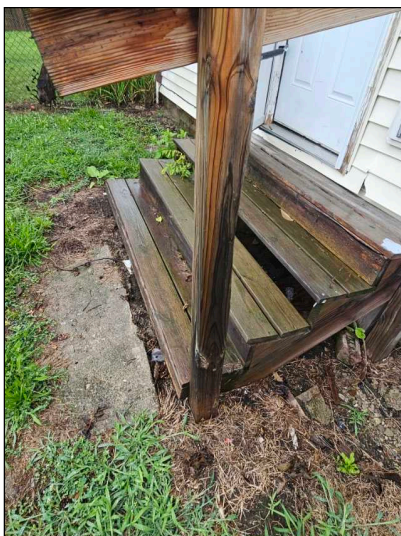
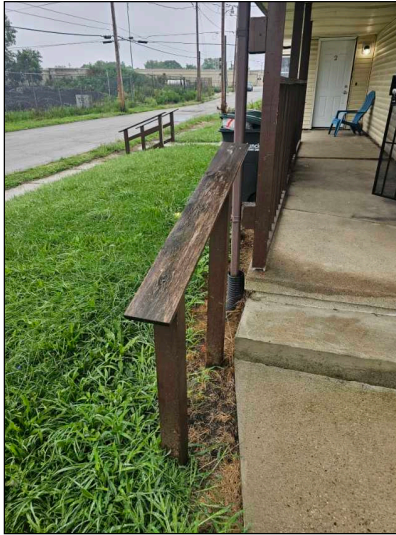
## 5. Stairs & Handrail

- Handrails are not graspable. By today's standards, rails should be configured so that a hand may grasp around a rail for safety. Recommend replacement by a qualified contractor.

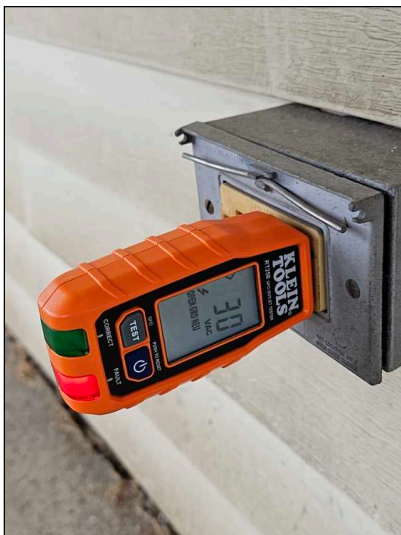
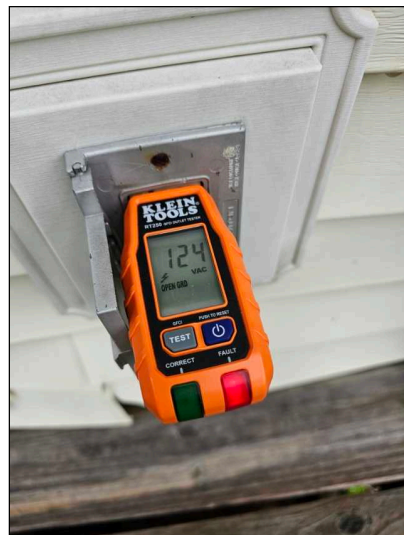
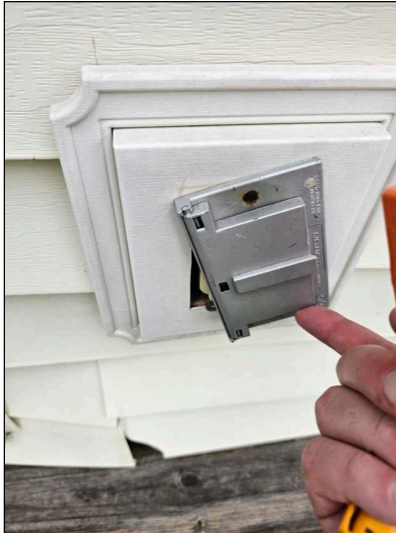
## 6. Grounds Electrical

- Open ground/neutral observed on the GFCI outlet located on the front patio. This is an electrical shock hazard and repair/replacement should be completed by a licensed electrician.
- Both outdoor outlet covers were not secure to the receptacle boxes.
- Open ground fault observed on the outdoor GFCI outlet located near the back door of the property. Potential electric shock hazard. Recommend repair/replacement by a licensed electrician.

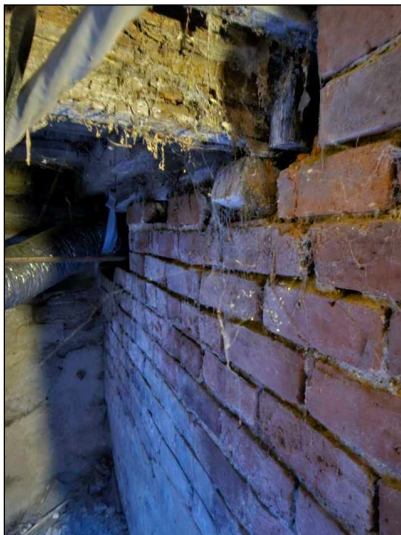
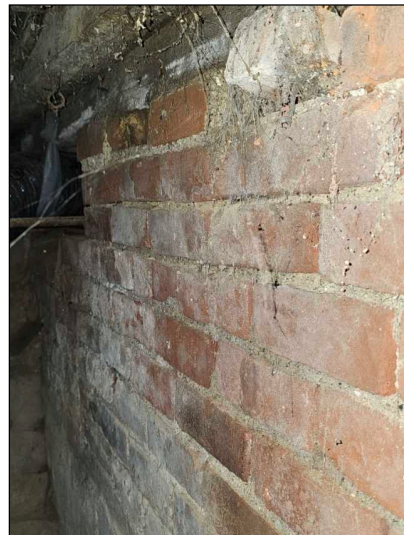
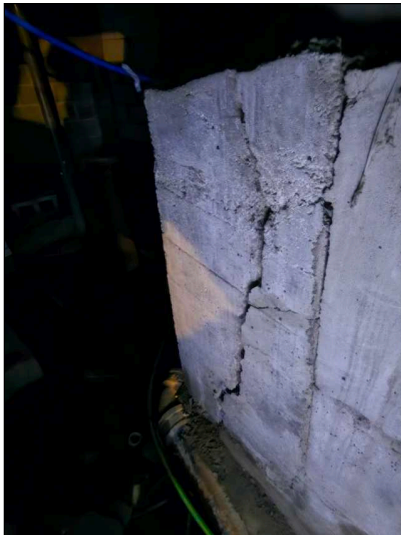
- It had rained heavily the day before and was misting at the time of inspection. Recommend having a licensed plumber
- Visible portions of foundation wall were dry at the time of the inspection.
- Large cracks were observed at the visible foundation walls. Repairs can be expensive and further settling or damage could occur. Recommend a Structural Engineer to provide a detailed analysis.
- The mortar in the brick foundation walls is deteriorating. Recommend further evaluation by a structural engineer.

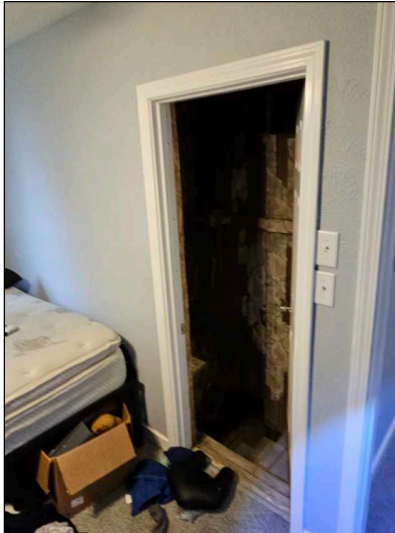
- Interior door was difficult to open and close. Recommend repair/replacement by a qualified contractor.

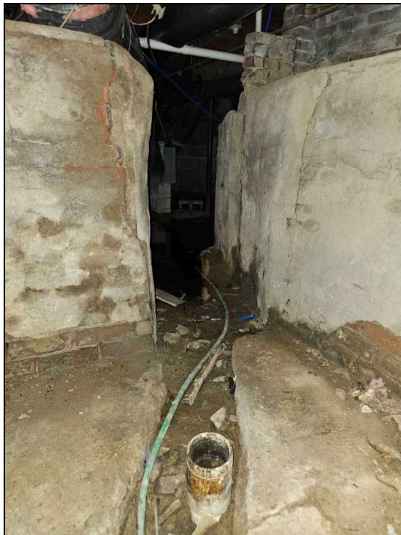
- Standing water noted on slab at time on inspection, review and repair needed to prevent possible water damage.
- Majority of the basement was inaccessible. Recommend a foundation specialist further evaluate the basement floor and walls once the standing water issue is resolved.

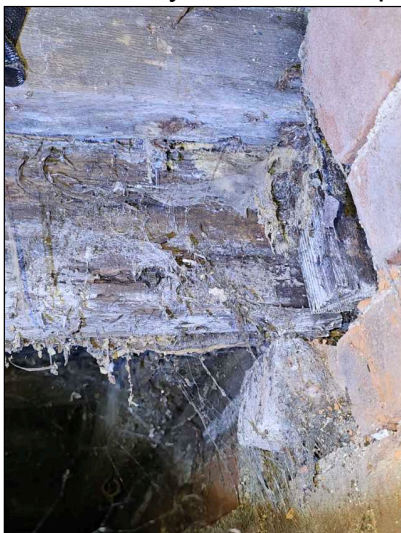
- **\*\*JOISTS\*\***
- Deterioration/ damage of one or more floor joist noted. Recommend review and repair by a Qualified Contractor to evaluate load bearing members.
- Recommend review of floor support system by a qualified contractor for any repair or upgrades needed to structure.
- Not fully visible for inspection due to lack of access to all areas.
